## MIFACE INVESTIGATION: #03MI052

### SUBJECT: Farm Youth Died When He Became Entangled in an Unguarded PTO Shaft

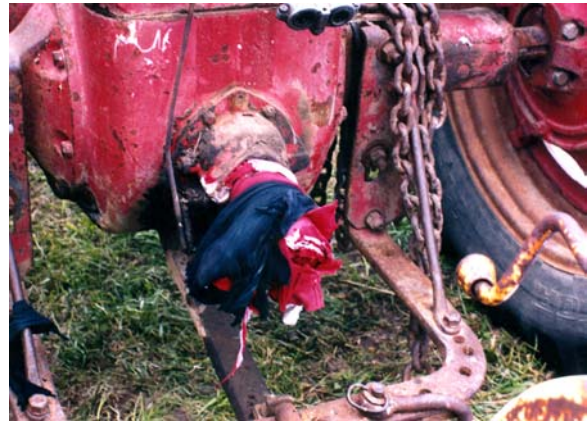
On May 23, 2003, a 13-year-old farm youth was killed when he became entangled in an unguarded rotating power take-off (PTO) shaft at the rear of his narrow front Farmall Model M tractor. (See Figure 1) The youth and his teenage cousin were raking hay in a field that had been cut a few days prior on an adjoining property. Both were driving narrow front Farmall Model M tractors equipped with a non-PTO powered hay rake designed for attachment to the tractor's drawbar. Neither tractor had a PTO master shield installed. The victim's tractor was ahead of his cousin's tractor and as he had already finished raking, had driven the tractor up near the barn. The victim's tractor had an owner-modified

Figure 1. Clothing entangled on bolt on PTO tractor stub shaft

- All rotating shafts, including tractor stub shafts, should be covered by shields/guards in good condition when the tractor is operated.
- Tractor operators should always disengage the PTO, shut off the engine, and if applicable, remove the key before getting off of the tractor.

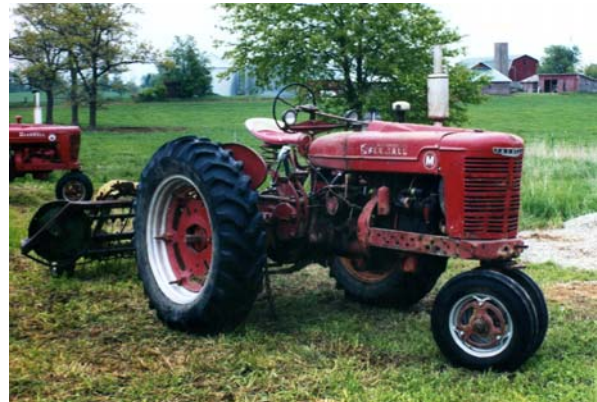
Figure 2. Tractors parked at incident site

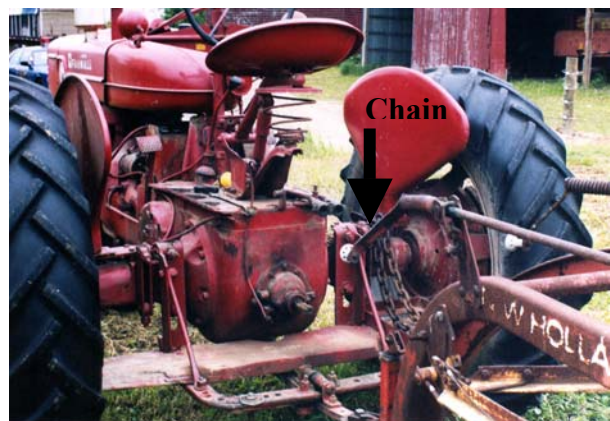
Each tractor was equipped with a non-PTO powered hay rake attached to the tractor drawbar. Both tractors had a board placed along the drawbar frame to assist in climbing on and off of the tractor. The tractor was normally mounted and dismounted by climbing on/off at the rear of the tractor instead of the side. The distance between the drawbar and the ground was approximately 18 inches. On the victim's tractor, there was a chain wrapped around the tractor axle. The axle was approximately 21

Figure 3. Board, chain and rake attachment on victim's tractor

inches from the ground. To step out from the tractor seating area to outside of the drawbar was 22 inches. (See Figure 3)

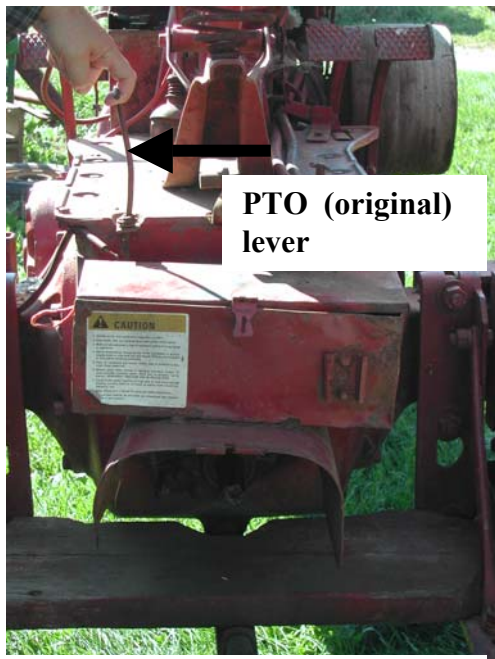
The tractor the victim's cousin was operating did not have an owner-modified extension PTO extension lever. The PTO activating lever on this tractor was located on the operator's left at the rear of the seat. (See Figure 4) To operate the power take-off with the tractor standing still, the

Figure 4. Original PTO engagement configuration

gearshift lever must be in neutral position. The operator must disengage the clutch and pull the power take-off shifter rod all the way up, then slowly engage the clutch. The original shifter rod required that the tractor operator turn around while in seated and pull up on the lever to activate the PTO. Note: The victim's father mounted PTO master shield seen in Figure 4 after the incident.

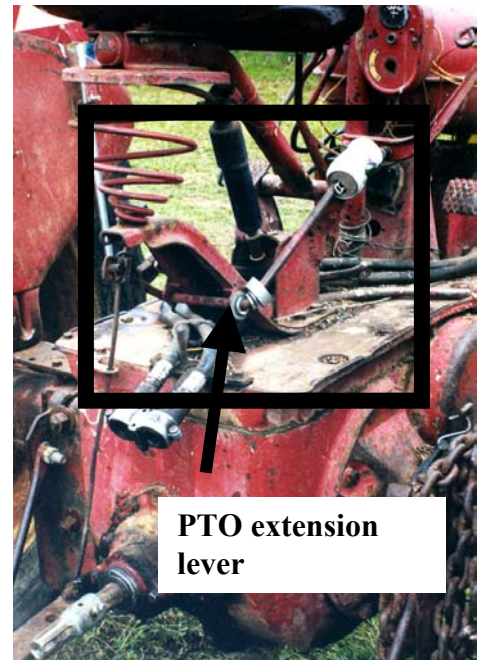
Figure 5. Owner-modified PTO extension lever

The victim's tractor had an owner-modified extension lever to activate the 540-rpm PTO (See Figure 5). The victim's father added an aftermarket extension lever to activate the PTO because the PTO shaft was worn when the tractor was purchased. (See Figure 5) The aftermarket extension located allowed the operator to activate the PTO without turning around. The extension attached to the original lever extended to a pivot point at the top of the axle housing and then extended under the seat. This lever handle was approximately a one-half inch diameter steel rod with an aluminum pop can that was used as a handle over the end. To engage the PTO, the extension lever must be pushed forward. The PTO replacement parts were at the farm but had not yet been installed. The victim's cousin's tractor did not have the extension lever.

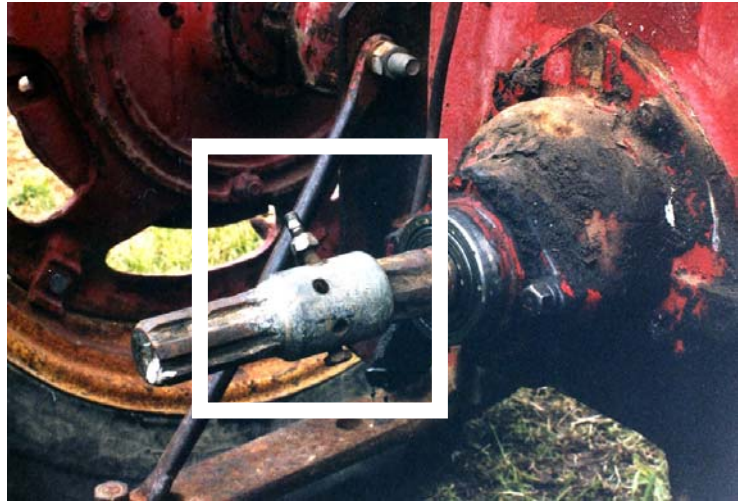
The PTO shaft on the victim's tractor had a six-inch extension bolted to the original shaft with a 5/16-inch bolt that protruded from the shaft by about 1-1/4 inches. (See Figure 6) According to the police report, the PTO master shield had been missing for an extended period of time as evidenced by the buildup of dirt and grease around the anchoring bolts.

Figure 6. Unguarded PTO extension bolt

- All rotating shafts, including tractor stub shafts should be covered by shields/guards in good condition when the tractor is operated.

MIFACE also recommends that a PTO stub shaft guard be used to completely enclose the tractor stub shaft when the PTO is not being used. The stub shaft guard will not only protect the operator but also keep the PTO stub shaft clean and in good condition. PTO shaft extensions cannot be adequately guarded with an original equipment or tractor manufacturer's PTO master shield.

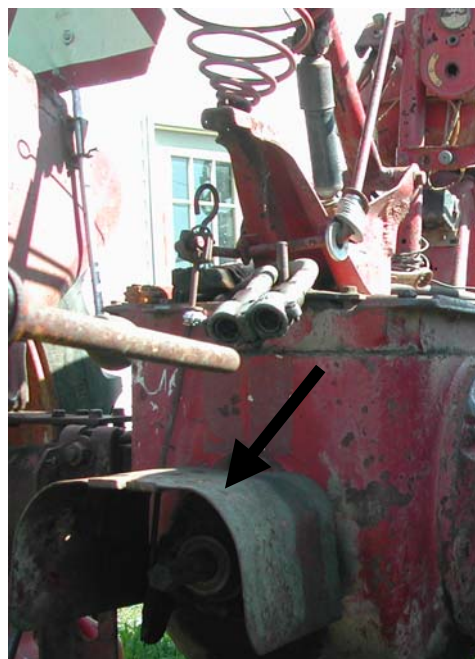
Figure 7. PTO Master shield in place after incident

After the incident, the victim’s father was able to obtain two master shields by attending antique tractor shows. He had been previously unable to obtain the master shields at his local tractor supply store. Properly designed guards and/or shields should cover any rotating shafts that an individual may be exposed to.

A total shielding system for a PTO driveline includes a tractor stub master shield, the PTO driveline shield and an implement shield. The master shield prevents the operator from accidentally coming into contact with the tractor stub shaft. This tractor was normally mounted and dismounted from the rear. When a PTO master shield is used as a step for the operator to mount or dismount the tractor, it must have sufficient strength to prevent it from being permanently deformed when stepped on by a 250-pound operator. (MIOSHA Agricultural Health and Safety Standards, Part 53, Farm Field Equipment (29 CFR 1928.57)).
