Orchard Tractor Operator Run Over By Trailer-Mounted Water Tank

Industry: Apple orchards

Task: Operating tractor towing water tank

Type of Incident: Tractor-related/Run over

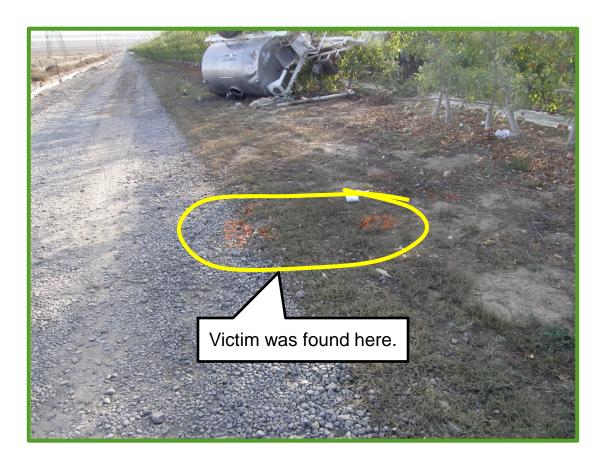
Investigators found the water tank trailer separated from the tractor. A piece of broken wire was found in place of the required safety bolt on the trailer's coupler. This wire broke either just before or after the victim came off the tractor, allowing the separation of the trailer from the tractor's hitch. Also, the tractor did not have a rollover protective structure (ROPS) or a seat belt. It is possible that the victim could have survived if the tractor had a ROPS and he was wearing a seat belt.

Incident scene looking downhill showing where the victim was found. The trailer-mounted water tank is lying on its side. The tractor which separated from the trailer is located behind the row of apple trees.

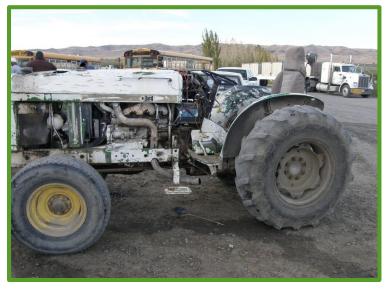
Tractor involved in the incident. It did not have a rollover protective structure (ROPS) or a seatbelt.

- Train employees how to safely operate tractors that they will be required to use. See WAC 296-307-08018.
- Maintain in a safe condition towing connections between tractors and all equipment and remove from service if in need of repair. See WAC 296-307-07001.
- Ensure that tractors are equipped with a rollover protective structure (ROPS) and a seat belt and ensure that employees use the seatbelt. See WAC 296-307-08009, and 296-307-08012.

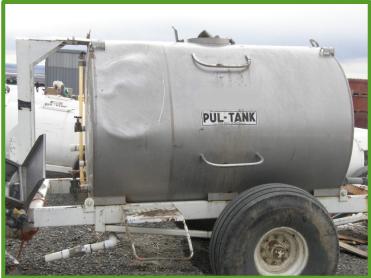
1,000-gallon capacity trailer-mounted water tank that was being towed by the tractor.

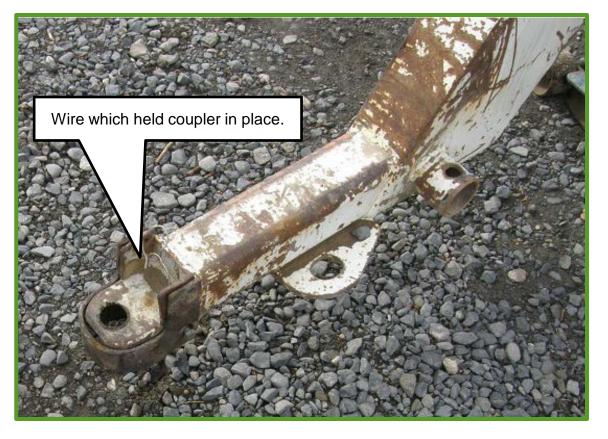
Coupler and water tank trailer tongue after the incident. A piece of wire was used to replace the missing locking bolt.
