## **MIFACE Investigation Report: #13MI009**

### **Subject: Assistant Manager at Fertilizer Mixing Facility Dies When Pinned Under Overturned 1972 Tractor Without a ROPS**

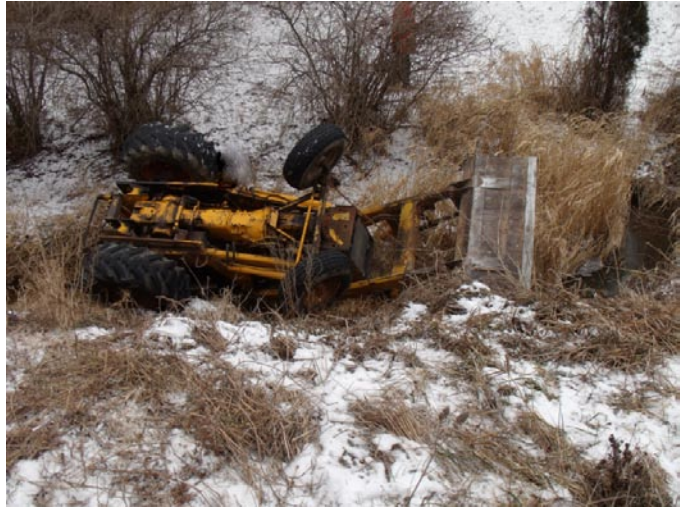
In the winter of 2013, a male fertilizer mixing facility assistant manager in his 30s died when his 1972 Case 580B Construction King tractor with a front end loader overturned after sliding down the walls of a drainage ditch. The tractor was not equipped with a roll over protection structure (ROPS) and seat belt. The decedent had unsuccessfully attempted to remove a 12-foot section of the rail of a railroad on the south side of the facility with the tractor bucket. The facility's General Manager determined that another method should be used to remove the rail. The decedent was in the process of backing the tractor away so he could move it to another area. The tractor length, including the bucket was approximately 15 feet. The decedent backed the tractor approximately 20 feet. The ground was snow covered. The back wheels of the tractor slipped into an approximate nine-foot-deep ravine with an unmarked edge. As the tractor was sliding down the ditch, he attempted to drive the tractor forward, but the tractor continued to slide into the ravine. When the front wheels of the tractor reached the edge of the ravine, the tractor overturned to the rear. The decedent was pinned against the ravine bank by the tractor seat. A ROPS was an optional piece of equipment when the tractor was built in 1972.

Figure 1. Tractor overturned in ditch

- Tractor not equipped with a ROPS and seatbelt
- Edge of embankment not marked
- Frozen, snow-covered ground
- Two-wheel drive tractor was not equipped with chains for traction

police found the tractor transmission in forward. The tractor continued to slide into the ditch. When the front wheels of the tractor reached the edge of the ditch, the tractor overturned to the side. The decedent was pinned against the ditch bank by the tractor seat.

- Retrofit older tractors with properly designed and manufactured ROPS and seat belt. If a ROPS is not available, consider replacing the older tractor with a tractor which can be equipped with or already has a ROPS.

The tractor involved in this incident, manufactured in 1972, was not equipped with ROPS or a seatbelt, which protect the operator in the event of a rollover. ROPS first became available as optional equipment on farm tractors in 1971, but were not required to be installed by tractor manufacturers until October 25, 1976, when OSHA Standard 29 CFR 1928.51 went into effect. Older tractors can be equipped with a ROPS and seatbelt. There are two basic types of ROPS for farm tractors: protective frames (two- or four- post structures attached to the tractor chassis) and protective enclosures (cabs or enclosures built around a protective frame). ROPS are designed to help limit a tractor overturn to 90 degrees and to provide the operator a "zone of protection". The operator must stay within this zone.

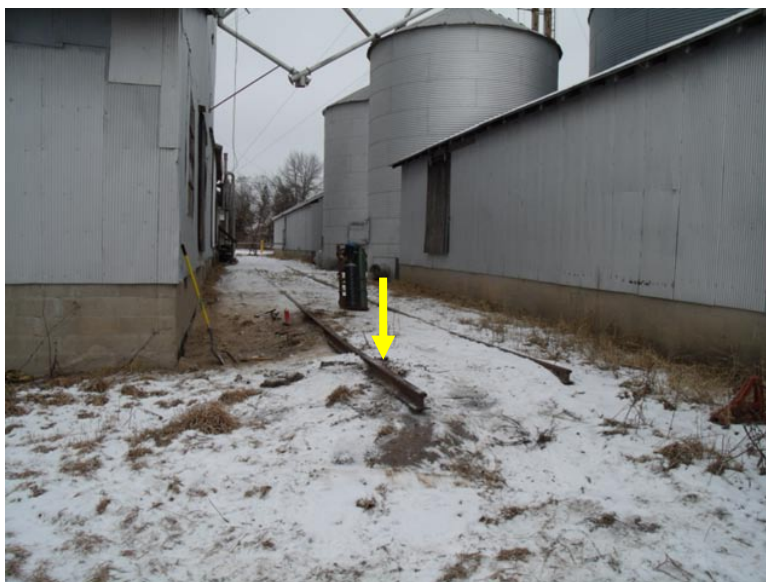
Figure 2. Identification (yellow arrow) and location of railroad spur being removed

A non-utilized railroad spur was located between two buildings, making it difficult to access an entrance to a feed building. The employer determined that 12 feet of the spur should be removed for building access, and as a precursor to a remodeling project that was scheduled for the spring.

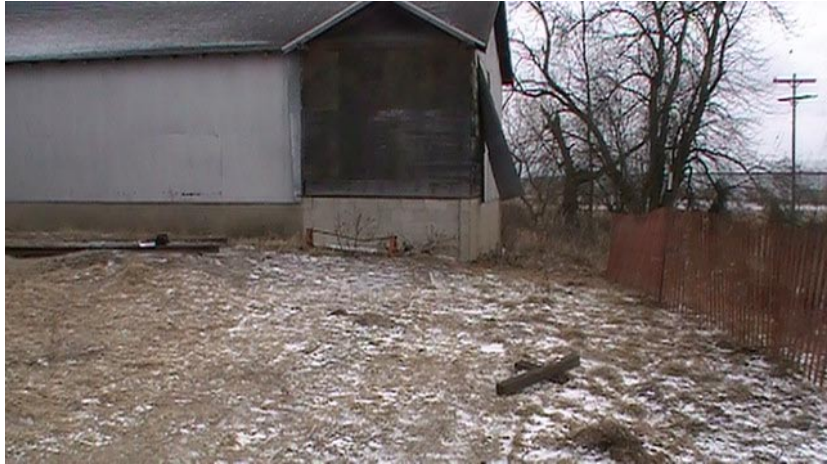
Approximately 20 feet from the end of the railroad spur was an approximately nine-foot-deep drainage ditch. The ground sloped gently from the spur to the edge of the ditch, which was unmarked. The ground was frozen and lightly covered with snow (Figure 3).

Figure 3. Overview of incident site after incident. Note orange fence installed by employer at embankment edge.

The employer installed orange plastic fencing at the edge of the ditch to define the edge location (Figure 3).

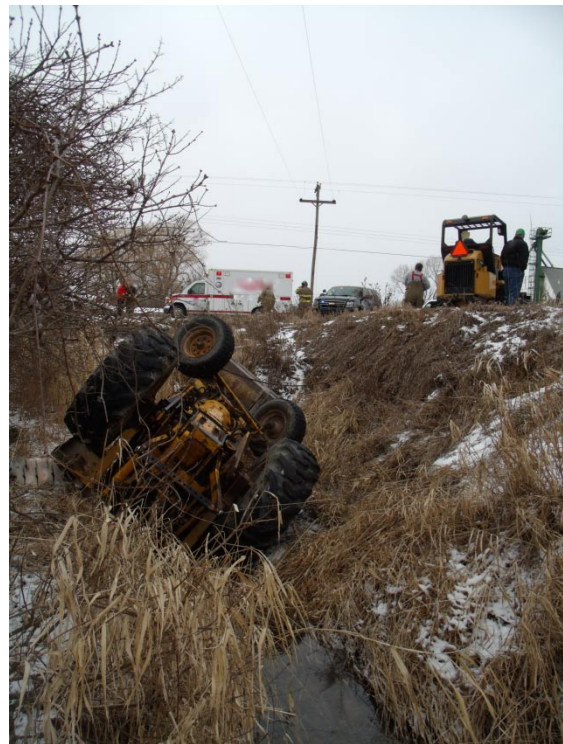
As the decedent backed the tractor, he apparently misjudged where the edge of the ditch was located. The tractor's rear wheels went over the edge and the tractor began to slide into the ditch (Figures 1 and 4). It is postulated that the decedent attempted to drive the tractor out of the ditch; responding

Figure 4. Final resting position of tractor. Note embankment slope.

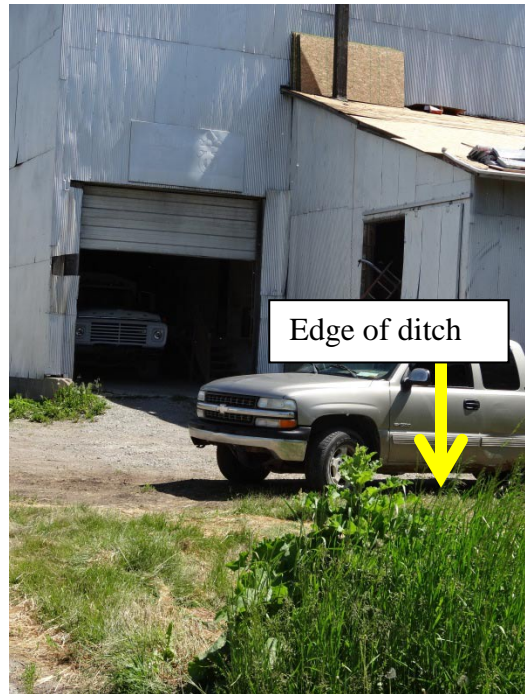
routinely traveled work area on the site, although when vehicles exited the loading area, if a vehicle malfunction or driver error occurred, the vehicle could enter the ditch (See Figure 5). After the incident, the management planned to install concrete highway dividers at the edge of the ditch to prevent a similar incident in the future. In the interim, the company had installed a flexible orange fence at the edge of the ditch. At the time of the MIFACE visit, the fencing had been removed days prior to accommodate the planned installation of the concrete highway dividers (Figure 6).

Figure 5. Embankment edge in relation to loading area.

- To alert workers, mark edges of an embankment with visual cues, such as elevated, reflective stakes, orange fencing, or permanent barriers when in a traveled work areas.

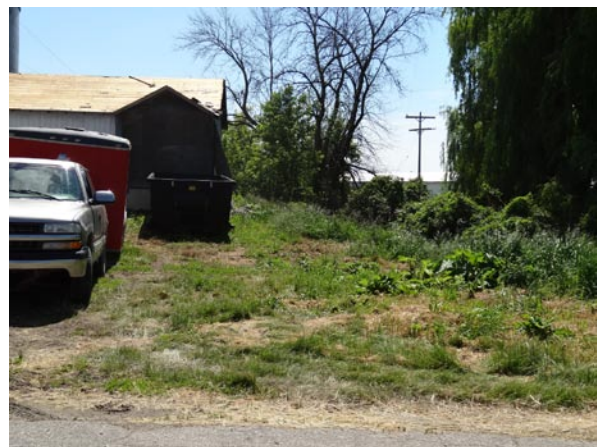
Figure 6. Embankment edge marking removed prior to installation of permanent barrier.

MIFACE recommends that companies do not remove such visual cues until the day of the installation of permanent barriers.
