# MIFACE Investigation Report: 12MI059

## SUBJECT: Land Owner Pinned by Tractor Bucket When Working in Ditch

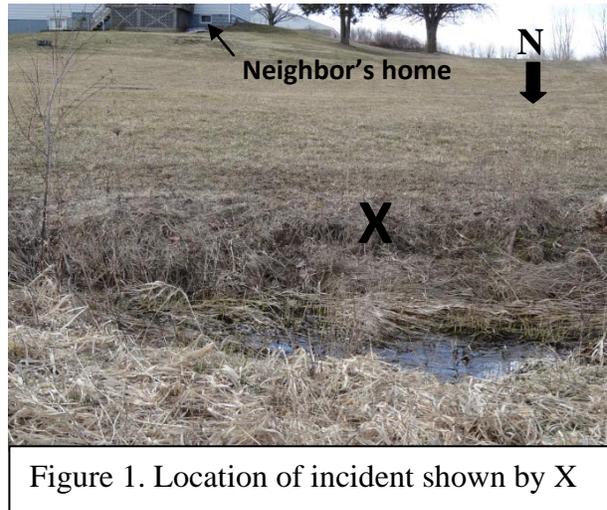
In summer 2012, a male land owner in his 70s died when his Massey Ferguson Model 65 tractor equipped with a front end loader bucket slid down a drainage ditch bank, pinning him between the bucket and the opposite ditch bank. He was clearing the ditch of weeds and small trees, for both drainage purposes and in preparation of repair to the culvert providing access to a field adjacent to his home that he rented to a farmer. The decedent placed the tractor on the south side of the ditch, near the ditch edge, with the bucket located over the ditch (See Figure 1 and Drawing 1). He

Figure 1. Location of incident shown by X

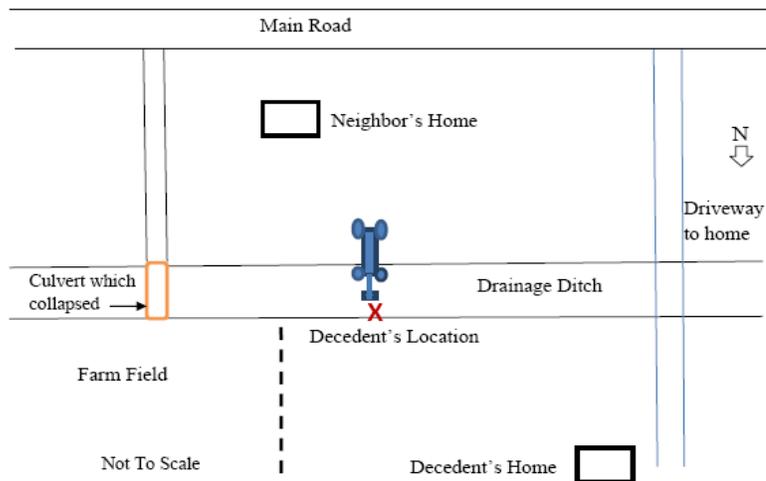
The decedent was a land owner who rented 10-15 acres of land to a local farmer to plant and harvest corn. Abutting the farm land he rented was a drainage ditch. The culvert to access the farm land crossed the ditch and was accessed via a two-track path from the main road. The drainage ditch separated two properties – the decedent's front yard to the north and a neighbor's back yard to the south (Drawing 1).

Drawing 1. Drawing of incident scene. Not to Scale.

On the day of the incident, his wife was working at the front of their home while the decedent continued to clear the ditch. He drove the tractor down the driveway and to the south side of the ditch, placing the tractor near the edge. The distance of the front wheels of the tractor to the edge of the ditch was unknown. Although fairly flat at the location of his work, the back yard had slight downward slope to the ditch. It is postulated that he used the same work practice as he did the previous week when working with his wife: dismounted, left the tractor in neutral, did not set the parking brake, did not block the tractor wheels, attached the chain to a poplar tree and the other end of the chain to the metal V-shaped piece on the bucket.

The actual sequence of events leading to his death was not witnessed and is unknown. It is postulated that the tractor vibrated causing movement toward the ditch due to the slope or when attaching the chain from the tree to the bucket, he pulled down on the bucket, facilitating tractor movement toward the ditch. The decedent's wife happened to look back toward the ditch. She saw the front of the tractor leaning into the ditch. She ran toward the ditch, yelling for help. A neighbor, who was inside the home with her boyfriend, heard the decedent's wife yelling and crying for help. When she looked out the window, she saw the decedent's wife by the tractor in the ditch. She yelled for her boyfriend to help assist the decedent's wife and she called 911.
