MIFACE Investigation Report #10MI069

SUBJECT: Hispanic Farm Laborer Electrocuted in Potato Field

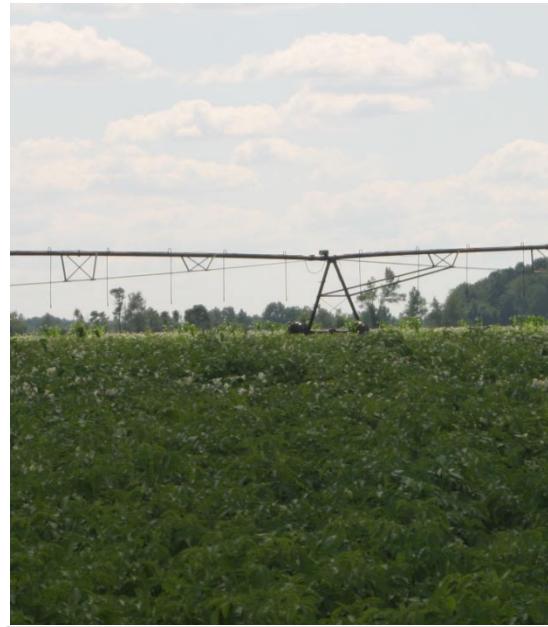
Figure 1. Irrigation unit involved in incident.

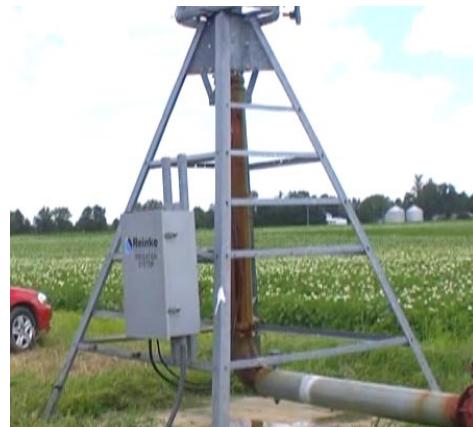
Figure 2. Center pivot involved in incident.

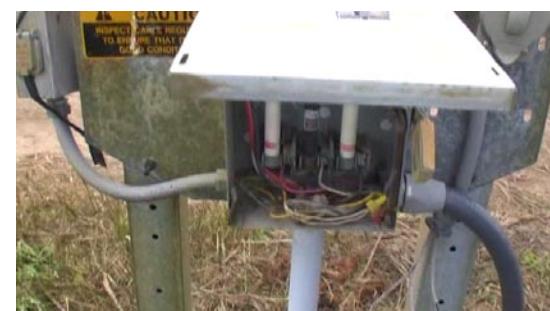
Figure 3. Power supply to Valley Pivot. Valley Pivot plugged into receptacle.

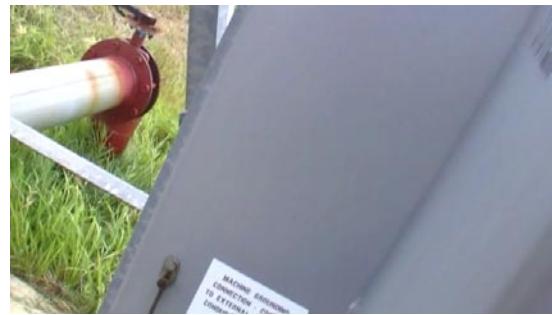
Figure 4. Machine ground of Reinke central pivot.

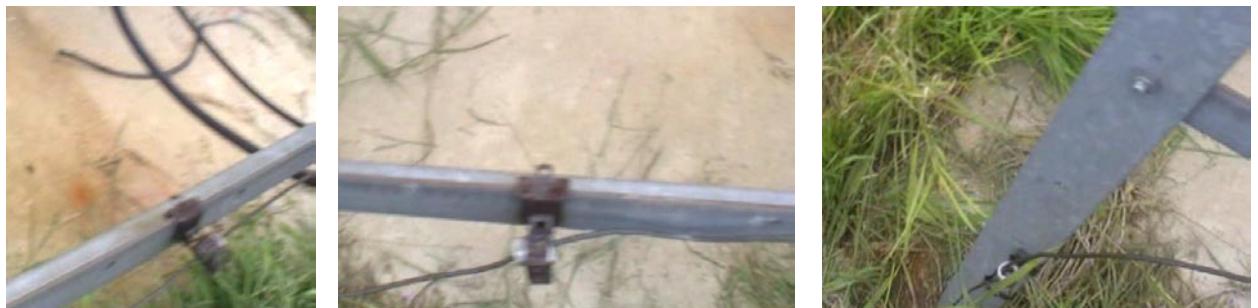
Figures 5-7. Path of Reinke ground wire.

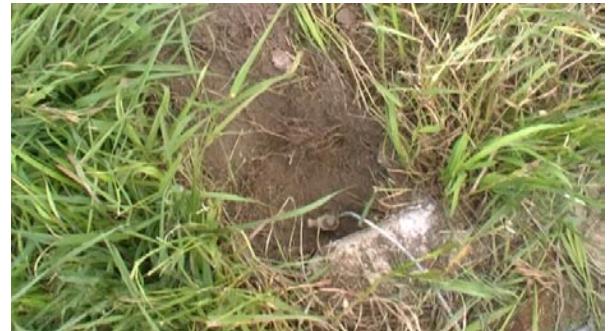
Figure 8. Machine ground of Reinke unit to ground stake.

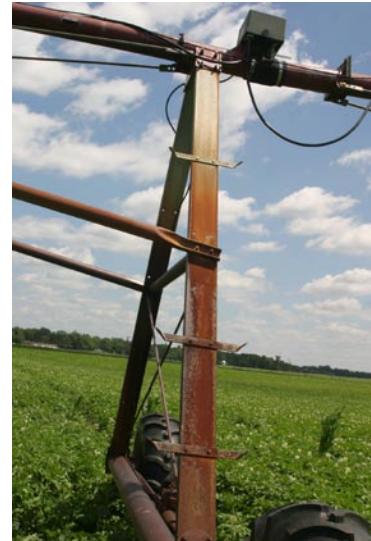
The electrocution occurred at the seventh single-leg tower associated with the Reinke center

Figure 9. Incident irrigation tower.

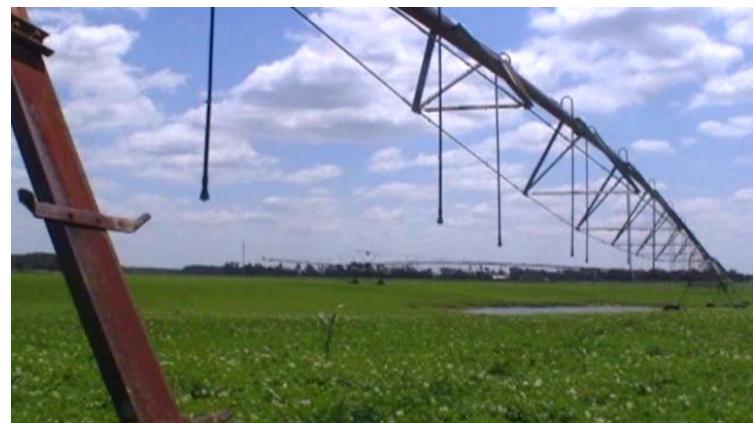
Figure 10. View of Valley and Reinke irrigation units. Reinke Center pivot would be located to the left of the tower.

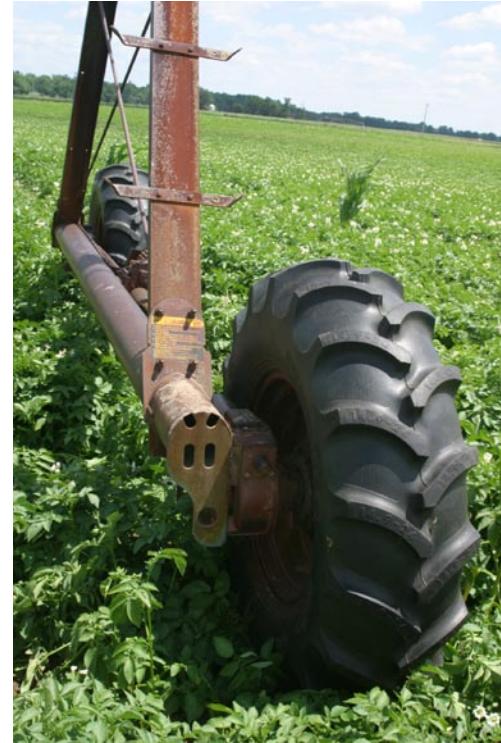
Figure 11. Close view of the base of the incident irrigation tower.
