Orchard Laborer Dies when Crushed Between a Motor Grader and Semi-Truck in Washington State

Investigation: # 09WA04701
Release Date: February 11, 2013
SHARP Report: #: 52-27-2013

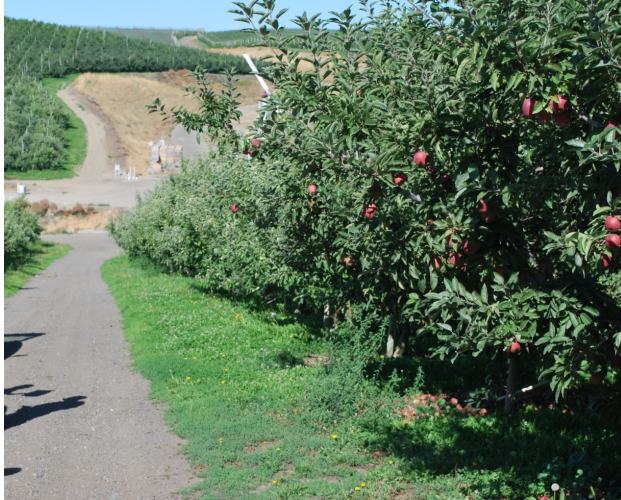
Orchard Road with 6-7% grade.

The semi-truck and flatbed trailer was at the orchard to pick up full apple bins. The semi-truck was traveling to a designated level area used for loading apple bins when it lost traction due to the 6-7% grade road and got stuck.

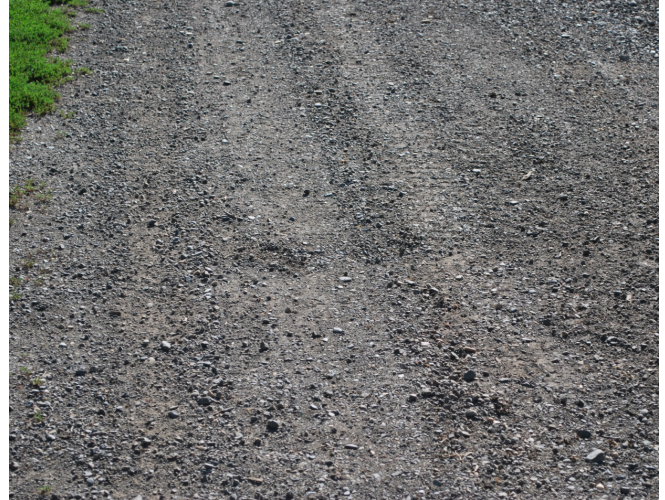
Close-up of gravel covering the orchard road.

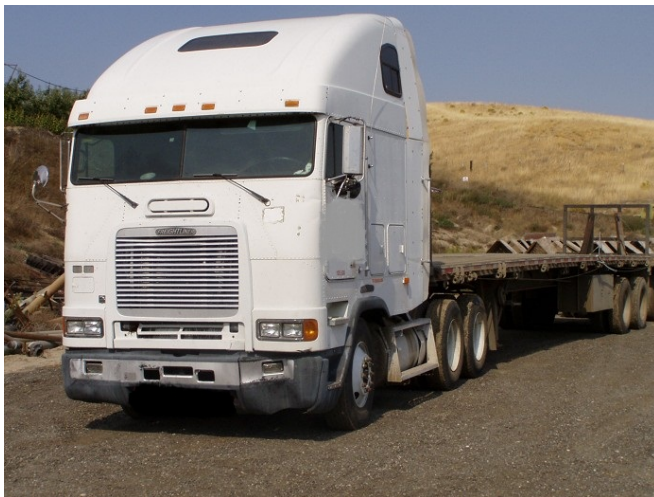
Semi-truck with flatbed trailer involved in incident.

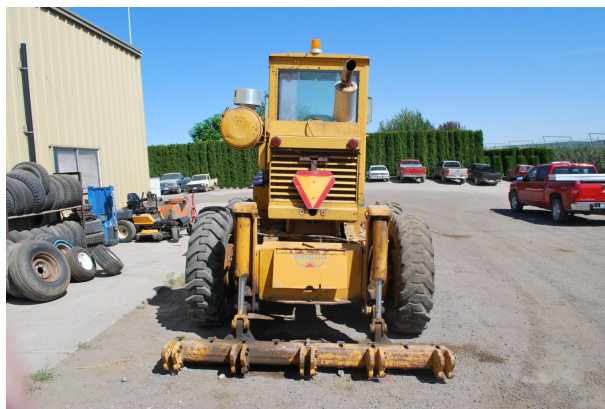
View of motor grader from rear.

According to the National Safety Council all motor graders, bulldozers, and scrapers should be equipped with an audible reverse alarm that operates automatically when the machinery is in reverse motion.³ The incident motor grader was not equipped with a reverse alarm. If it had a reverse alarm, the worker and semi-truck driver might have been less likely to remain in the crush hazard area. If heavy mobile machinery was manufactured without a reverse alarm it is recommended that employers either remove that piece of machinery from service, or have it retrofitted with a reverse alarm.

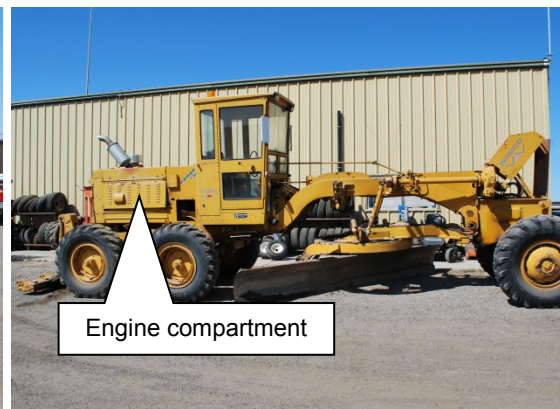
Side view of motor grader.

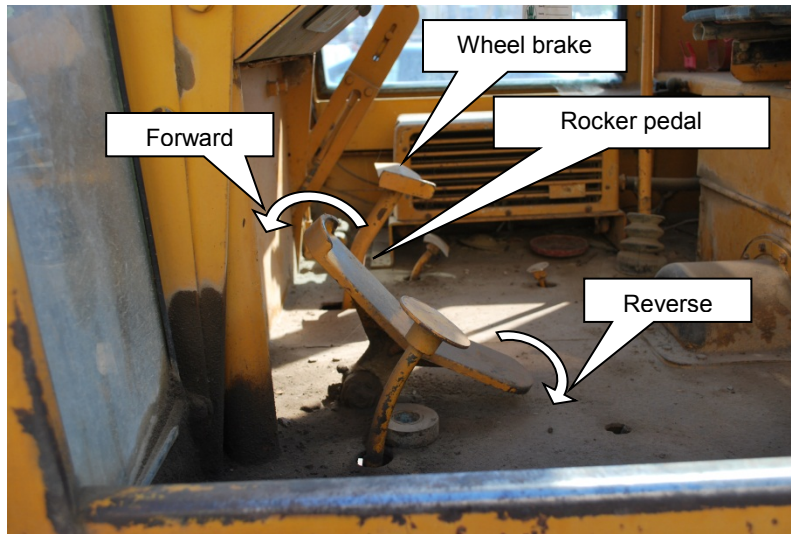
Rocker pedal and wheel brake.

According to manufacturer's manual, each of the four tandem wheels on the motor grader is equipped with a hydraulic actuated, shoe-type brake. The brakes activate when the operator pushes down on the wheel brake located to the right of the rocker pedal. The operator of the grader at the time of the incident said that the brakes failed and he was unable to stop it as it was backing up. The operator said that the brakes often needed to be pumped before they would work completely after the grader had not been used for at least a week.

After the incident the DOSH inspector tested the traveling and emergency brakes of the motor grader on the orchard road where the incident occurred. The inspector did not find any brake fluid leaks, and both the traveling brakes and the emergency brakes prevented movement of the grader on the sloped road.

Two eye witness reports claimed that the motor grader came to a complete brief stop about 7 feet away from the semi-truck before suddenly reversing into the semi-truck. This indicates that the brakes may have been functioning properly at the time of the incident.

The operator reported that the motor grader had not been used in a couple months. Before using the motor grader, he did a quick walk around inspection but it did not include any functional testing of the hydraulic brakes and other safety systems. The operator also reported it was common for the motor grader to need the brake pedal pumped to work when it had not been used recently. If the brakes had been functionally tested, the operator could have identified and addressed any problems with the brakes before reversing the motor grader down a sloped road.

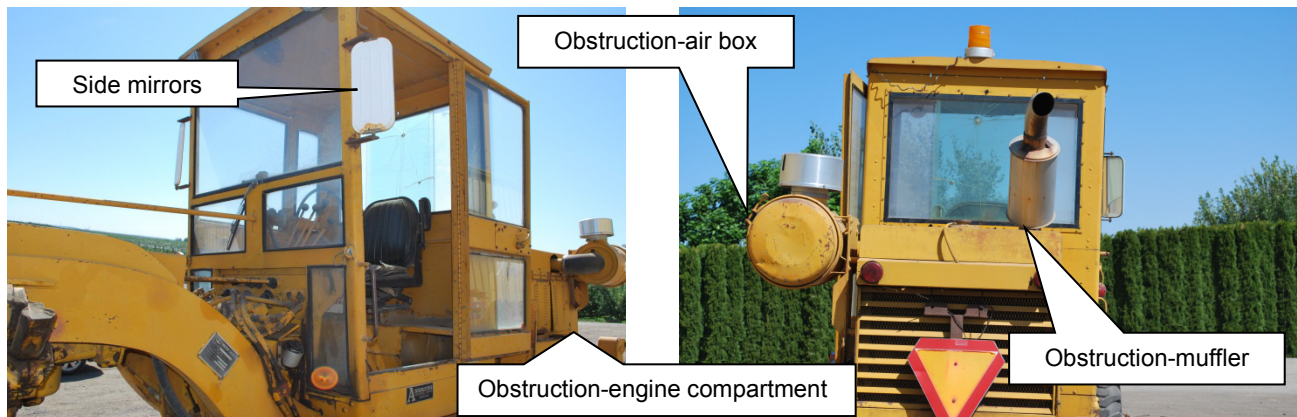
Side mirrors and back window (along with view obstructions) the motor grader operator would have used while reversing downhill.

Based on the inspection of the motor grader cab done by the WA FACE program and the managing partner, it is likely that the operator of the motor grader would have to stand in the cab and look over his shoulder out the back window beyond the rear of the engine compartment in order to see the worker and semi-truck driver while reversing the motor grader down the sloped road.

This motor grader was equipped with side mirrors. However, it still had blind spots for the operator. The height and length of the engine compartment created blind spots behind the machine that obscured the operator's view of the area where the worker and the driver were attempting to connect the chain. Diagrams 2 and 3, in appendix A, show examples of a motor grader operator's blind spots from the ground level and five feet above the ground (These blind spots were determined using a 27 ton CAT16G motor grader).⁴ For more diagrams characterizing machinery visibility for motor graders and other commonly used heavy machinery see NIOSH's Construction Machinery Visibility webpage at: www.cdc.gov/niosh/topics/highwayworkzones/BAD/imagelookup.html

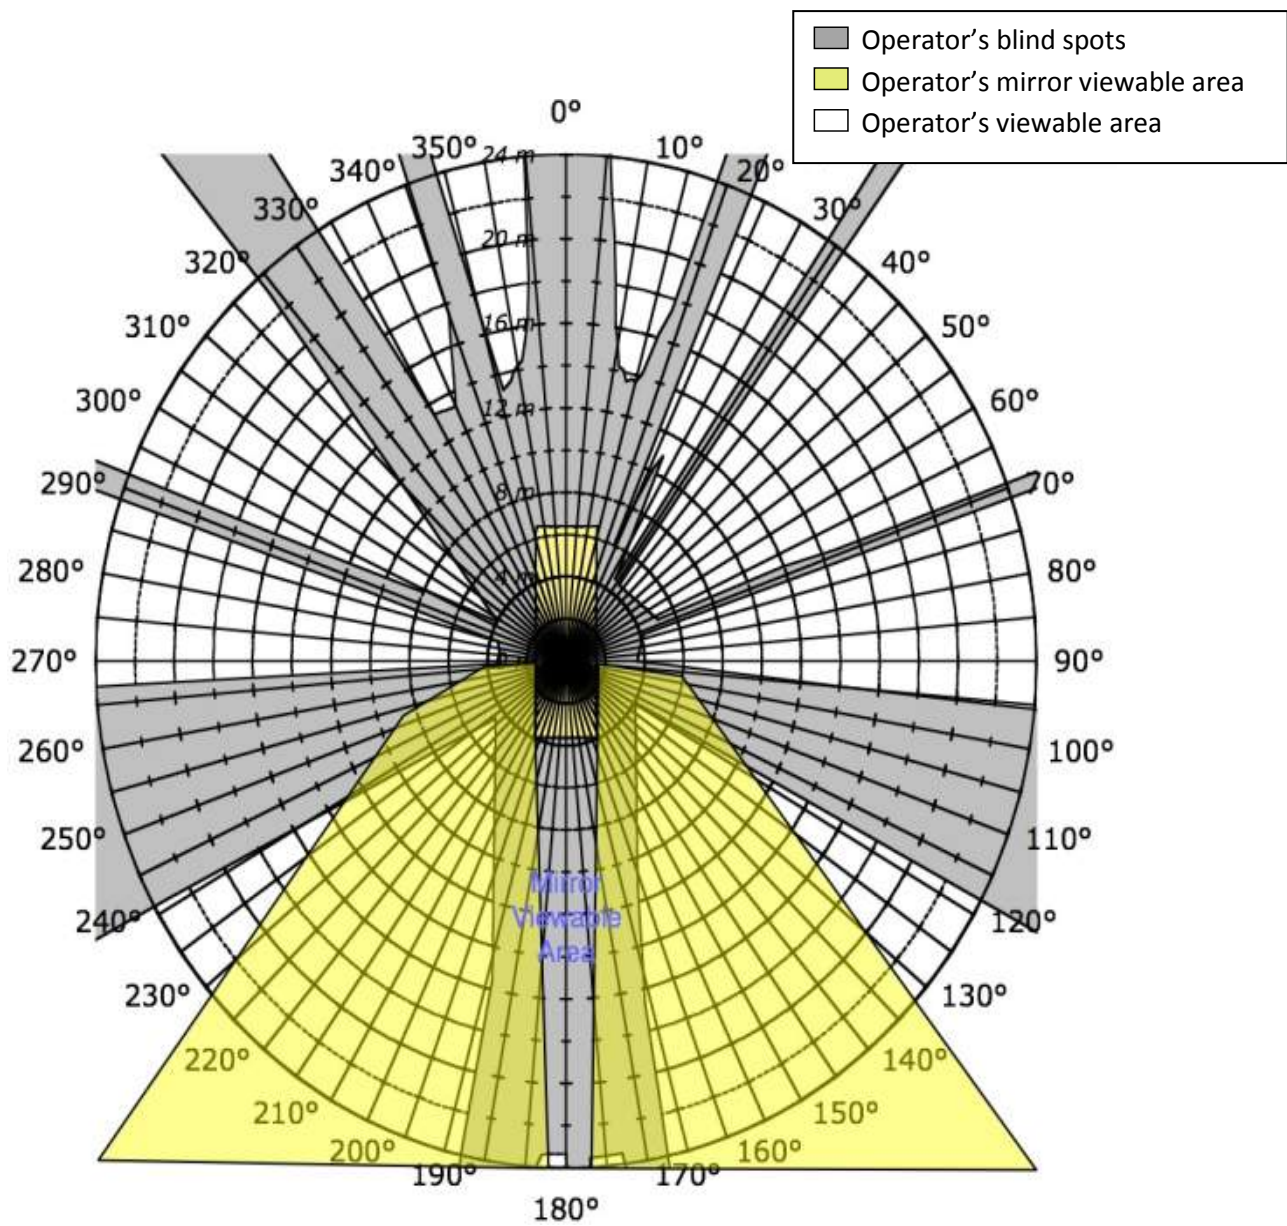
Diagram 2: Blind spots at ground level for a 27 ton CAT16G Motor Grader

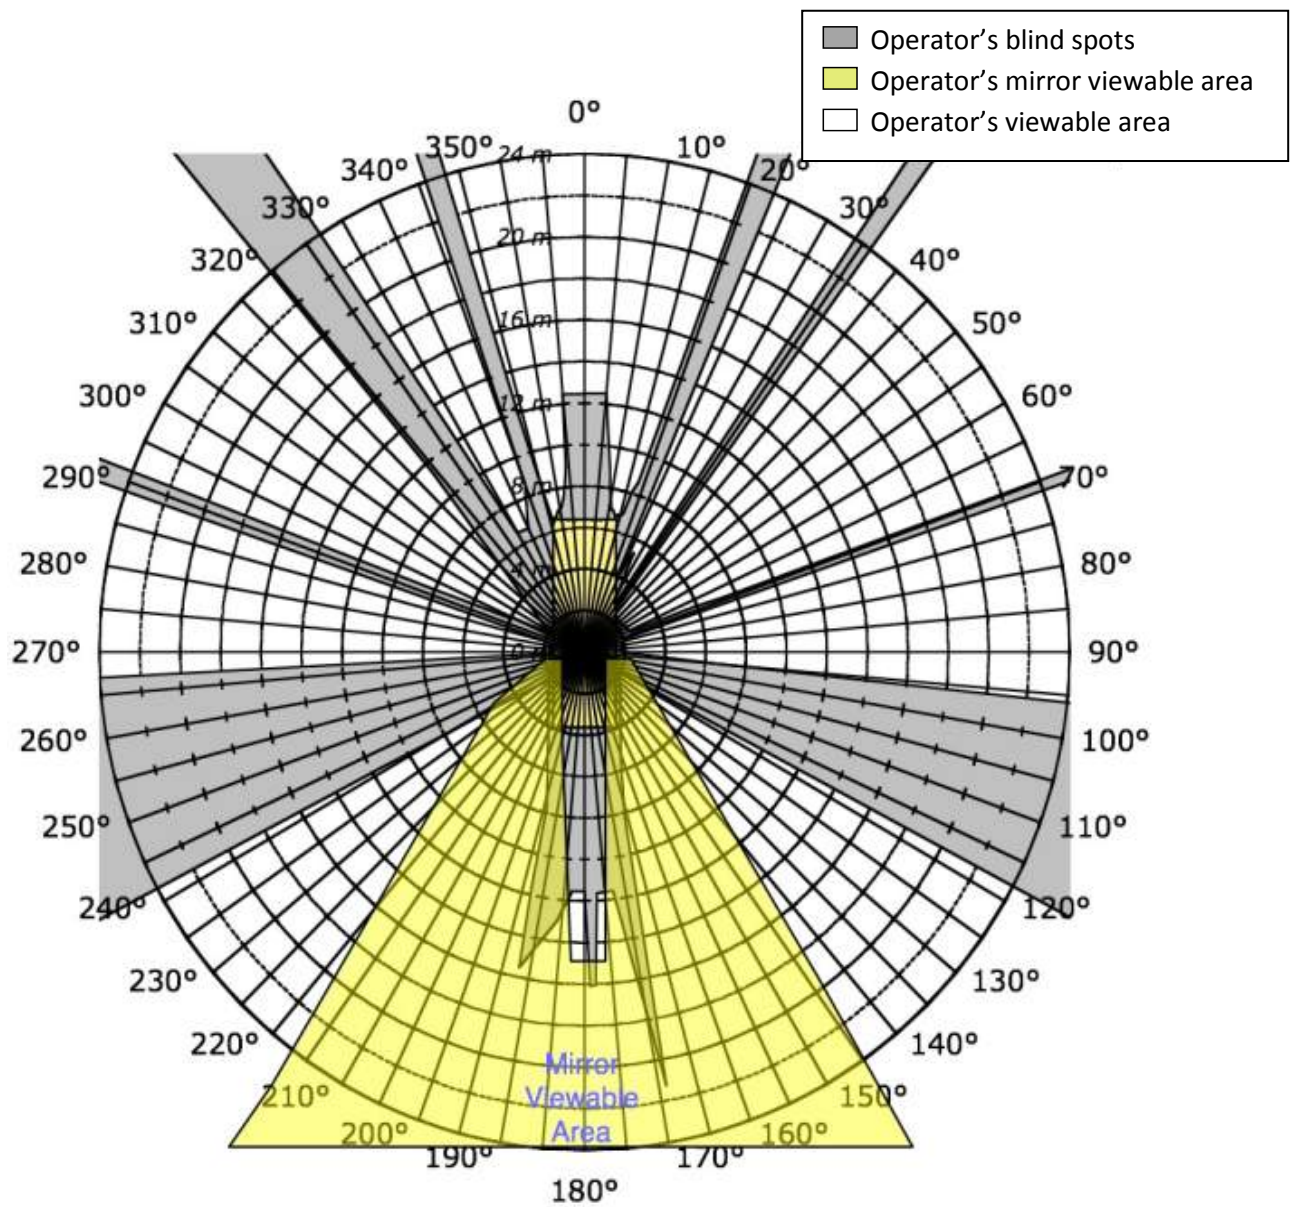
Diagram 3: Blind Spots at five feet above ground level for a 27 ton CAT16G Motor Grader
