What Really Happened- Photo 1

For Poster Display

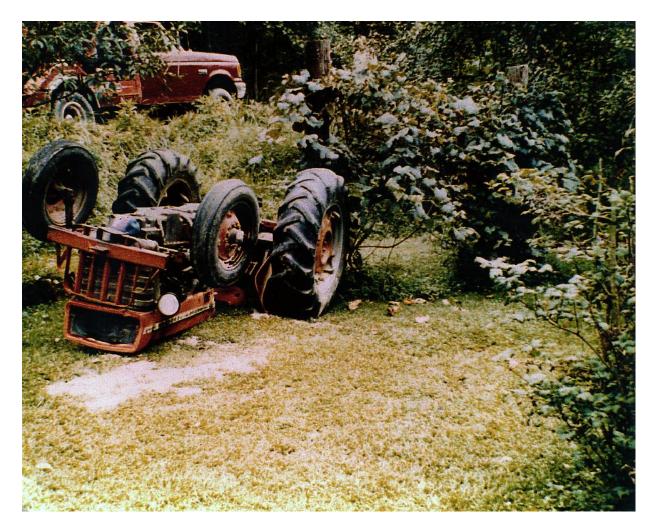
Photo 1 - Orange tractor, completely upside down

This experienced farmer was bushhogging for a neighbor. While traveling up the road where the truck is parked, he made a U-turn. The left tractor wheels dropped off the edge of the gravel road. The tractor flipped upside down. A neighbor witnessed the overturn. The local rescue squad raised the tractor, removed the farmer's body, and laid it out beside the tractor. The white substance beside and slightly ahead of the tractor is an absorbent used to soak up the blood where the body lay until the coroner arrived. If his tractor had a ROPS, and if he had worn the seat belt, the farmer almost certainly would not have been injured and would have walked away from the overturn.

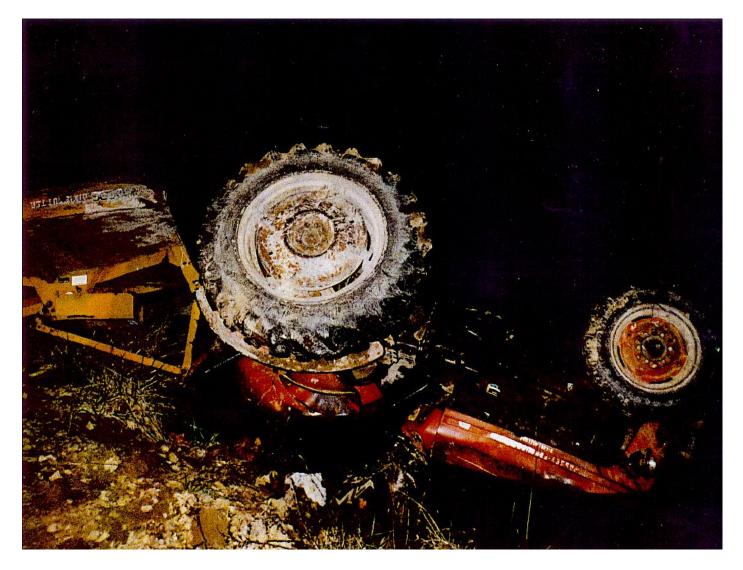
Photo 2 - Red tractor overturned in a stream

This experienced farmer was bushhogging a pasture along a stream bank when a portion of the bank collapsed. The tractor and the bushhog overturned into the creek. When he didn't come home, a family member went looking for him and found him after dark. The farmer's body was underwater in the creek, crushed beneath the overturned tractor. He drowned with his face and body pressed into the mud at the bottom of the creek. A ROPS and seat belt could have saved him. The ROPS would have held the tractor off the creek bottom and allowed him to unbuckle the seat belt and escape.

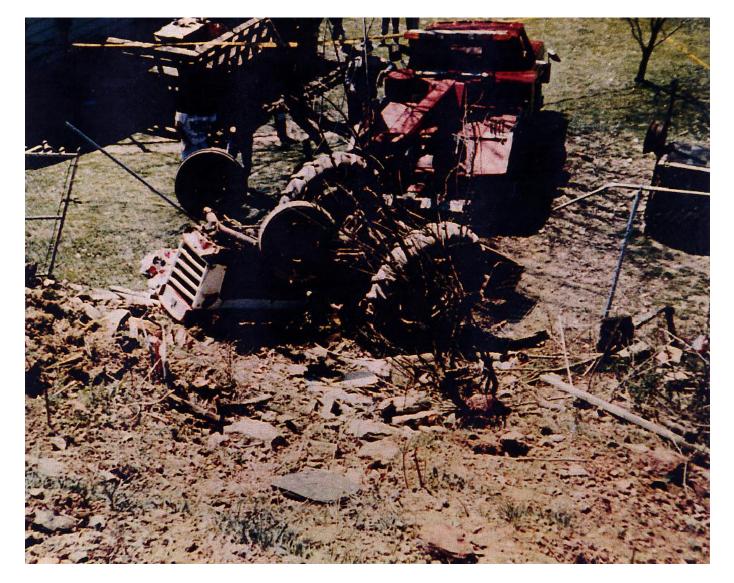
Photo 3 - Tractor with a white radiator overturned on a chain-link fence

This experienced farmer was using a box scraper on the back of his tractor to grade crushed stone on a gravel road. A heavy rain had washed the stone downhill and to one side. As the farmer moved the stone with the scraper, the left wheels of the tractor dropped off the side of the road. The tractor overturned crushing the farmer to death.

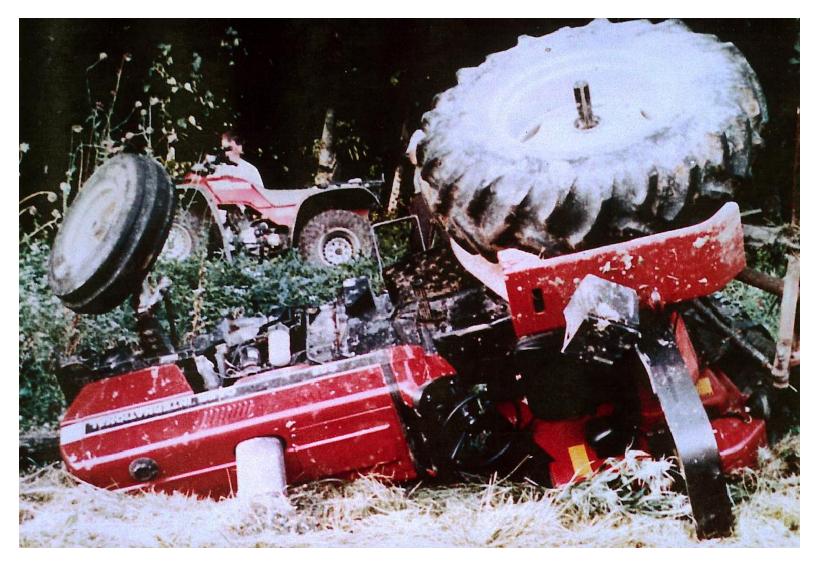
Photo 4 - Overturned red tractor with a ROPS

This experienced farmer was mowing the banks on a farm road that runs along the side of a field. The farmer says he remembers being careful and moving along slowly. Then the tractor's left wheels dropped off the edge of the road. The overturn happened in an instant. The next thing he remembers is crawling out from under the overturned tractor. He was not hurt. The ROPS prevented him from being crushed. The second photograph (4A) shows the tractor after it had been uprighted with only slight damage to the hood.

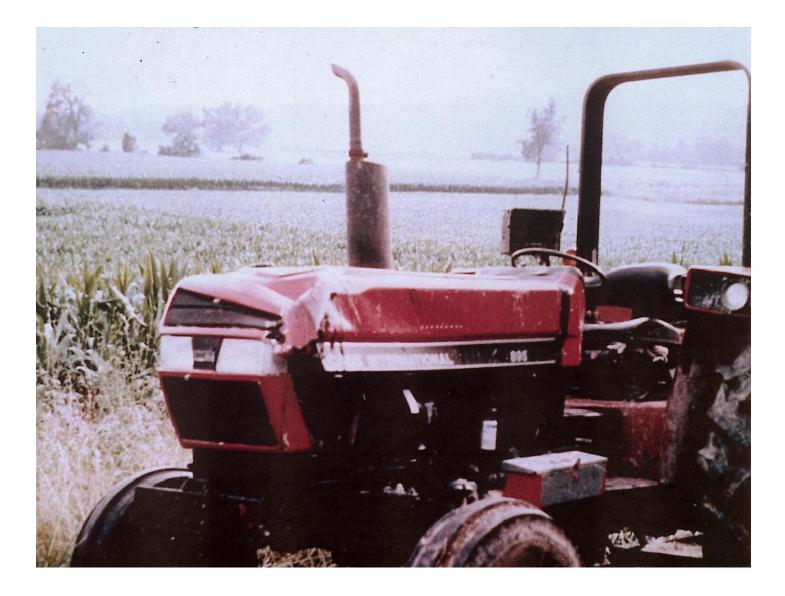
Photo 5 - Red tractor with a ROPS overturned into a creek bed

A 13-year-old boy was mowing along a creek bank when his tractor went over the edge and instantly overturned. The tractor was equipped with a Rollover Protective Structure (ROPS) that prevented the boy's body from being crushed by the tractor. He was thrown from the seat and his legs were pinned under the tractor. He required surgery to remove a blood clot from one leg, but was not seriously injured. If he had worn the seat belt, the boy would have stayed in his seat and not been injured. The second photo (5A) is a close up of the boy pinned under the tractor. The sheriff's department took the photos during the rescue. If there had been water in the creek the boy would have drowned. If his father had not seen the overturn, and the boy had remained trapped under the tractor for a few hours, he could have lost one or both legs.
