FATALITY NARRATIVE

Laborer Falls 12 Feet through Barn Roof

Incident Date: September 12, 2016
Release Date: November 6, 2017
SHARP Report No.: 71-164-2017

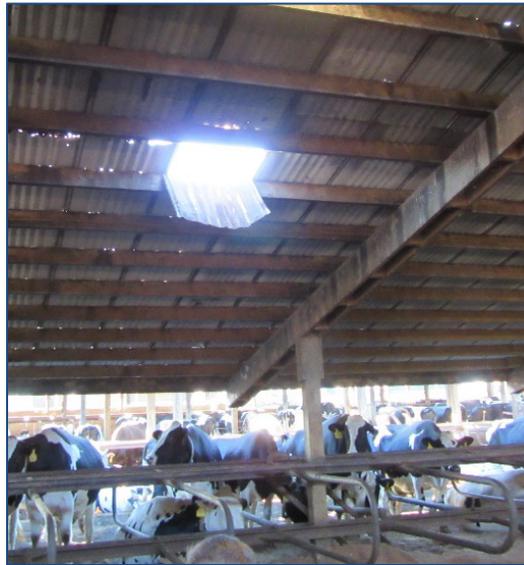
In September of 2016, a 54-year-old construction laborer fell 12 feet to his death when he stepped on a portion of the metal roof of a dairy cow barn and it gave way. It was his first day on the job working for his employer, a small general contractor. Investigators were unable to determine his construction work experience. A dairy farm owner hired the employer to do remodeling and make repairs around the dairy. For the past several years, the employer had done work around the farm. On the day of the incident, the victim and another laborer were working on a damaged barn roof. They were to replace the badly deteriorated metal roof peppered with rusty, pitted areas and damaged trusses. A year earlier, dairy workers had placed plastic sheeting on the roof as a temporary fix to prevent rain from coming through the damaged roof. The victim and the other laborer were prepping the 3/12 pitch roof for repairs by removing the plastic sheeting. The employer and the laborers were aware of how severely damaged the roof was. The employer did not require or provide fall protection and told the laborers to walk on the purlins, not the damaged

Incident scene showing the metal roof of a dairy barn through which a laborer fell 12 feet when a portion of the roof gave way. He was not using fall protection.

metal roofing. The laborers spent the morning and early afternoon working on the roof at heights varying from 7 feet at the eaves to 20 ½ feet at the roof peak. At approximately 3 p.m., the victim stepped on a metal roof panel that gave way under his weight, causing him to fall and land on concrete 12 feet below. He died of head injuries at the scene.

- Ensure that all surfaces on which employees will be working or walking on are structurally sound and will support them safely prior to allowing employees to work or walk on them.
See [296-155-24605\(1\)](http://296-155-24605(1))

- Ensure that the appropriate fall protection system is provided, installed, and implemented when employees are exposed to fall hazards of 10 feet or more to the ground or a lower level while engaged in roofing work on a low-pitched roof.
See [WAC 296-155-24611\(1\)\(a\)](http://WAC 296-155-24611(1)(a))

- Develop and implement a written fall protection work plan including each area of the workplace where the employees are assigned and where fall hazards of 10 feet or more exist.
See [WAC 296-155-24611\(2\)](http://WAC 296-155-24611(2))

- Conduct walk-around safety inspections at the beginning of each job and at least weekly thereafter.
See [WAC 296-155-110\(9\)](http://WAC 296-155-110(9))

- Develop and implement a safety and health plan based on a job hazard analysis (JHA) for each task workers are assigned to do.
