**Iowa FACE Report:** Farmer and his employee died after collapse and attempted rescue in manure storage pit  
**Case ID:** 2005 IA 024 / 2005 IA 025  
**Date:** 4 August 2014

A 52-year-old farmer and his 23-year-old employee died several days after exposure to manure gases in the pit beneath a cattle confinement building. Their deaths were attributed to exposure to toxic gases in the pit. Iowa FACE learned of the incident through media reports. A preliminary investigation was initiated in 2005, and an in-depth investigation was initiated with the family's permission in 2014. Telephone and in-person interviews were conducted with the farmer's wife and son, who were involved in the operation at the time and who became the primary farm operators following the fatalities. A site visit was conducted.

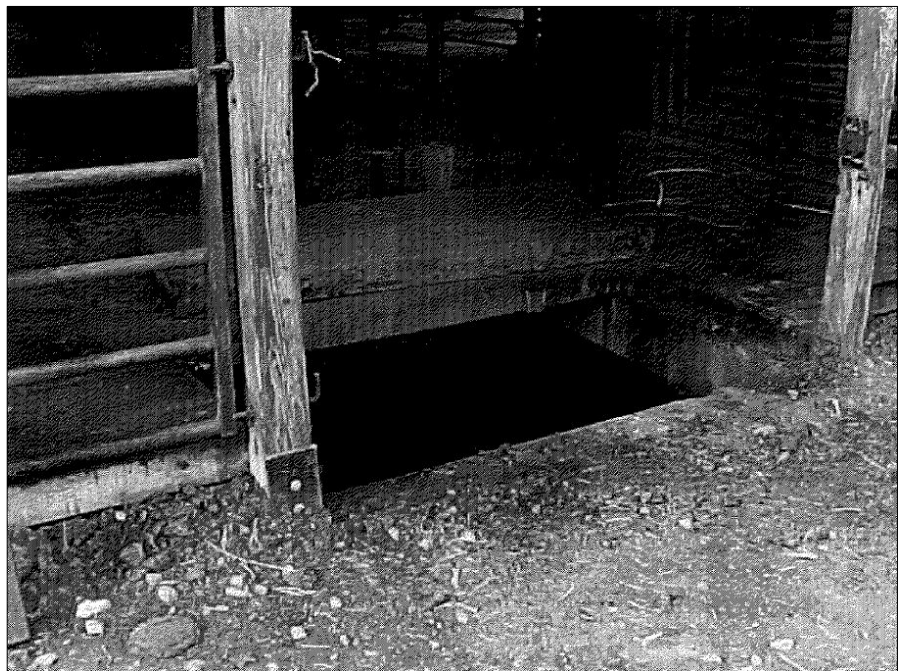
On a spring afternoon in 2005, a 52-year-old farmer and his 23-year-old hired hand were emptying manure from the pit beneath a cattle confinement shed at the farmer's homestead. After the job was finished at about 15:30, the farmer "climbed down" the vertical manure transfer pump that was in the pit, presumably to retrieve a chain that had fallen in the pit earlier that week. While in the pit, he collapsed and fell backward.

His employee either witnessed the collapse or discovered the farmer in the pit. He ran 150 yards to the farmer's house and told the wife to call 911 because her husband had fallen in the pit. The employee raced back to assist the farmer. He was followed by the farmer's daughter.

The employee then entered the pit in an attempted rescue. He, too, collapsed and fell face down in four to six inches of manure that remained in the pit. The farmer's father-in-law (who had come to the site by chance) and daughter witnessed the employee's collapse. After completing the 911 call, the farmer's wife rushed to the shed with a ladder to attempt rescue, but her father prevented her from entering. Within five to seven minutes of the 911 call, local firefighters and emergency responders arrived from the nearby town. Medical assistance was requested from a regional hospital 12 miles away.

An initial rescue attempt was made by an emergency responder wearing an air-purifying respirator. On his way into the pit, he had difficulty breathing and nearly passed out, but he managed to get back out of the pit. Firefighters then donned self-contained breathing apparatus (SCBA) respirators, entered the pit, and retrieved the unconscious victims. Medics took over care of the victims and transported them to the nearest hospital. From there, they were air-lifted to a tertiary-level hospital 70 miles away.

- **identify manure pits as confined spaces and post warning signs at building entry and pit access points**
- **train employees and inform family members, contractors, and other agricultural workers who may be at the site regarding hazards associated with manure pit environments**
- **follow confined space entry procedures which include testing the atmosphere, working with spotters and observers, and wearing appropriate safety equipment**
- **develop an emergency plan that is shared with workers and family members before a potential emergency arises; warn of the danger of attempted rescues**
- **consider purchasing or renting gas detection equipment to assess hazardous environments**
- **ventilate manure pit spaces before, during, and after agitation to dissipate toxic gases**

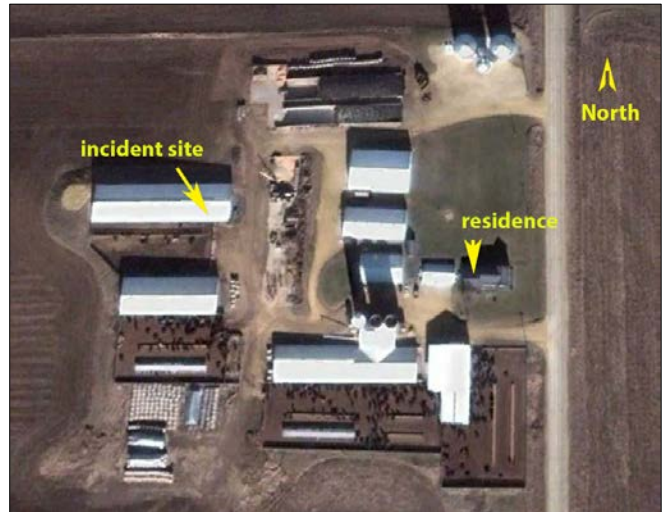
**B. North side of shed with manure spreader tank outside building**  
**Windows with white panel covers were added after the fatalities**  
(2014 photo)

The 200' x 60' cattle shed was constructed in 1975. It was enclosed on three sides with sliding doors on the east and west ends and three sliding-panel windows on the north wall (Exhibit B). The south side of the shed was completely open; it had steel gate partitions that opened to the adjacent lot (Exhibit C). The capacity of the building was 300 head.

The pit under this cattle shed (and many other livestock facilities still in use) was not configured with mechanical ventilation. While the above-ground area in the shed was completely open on the south side, and all windows and doors were open on the other sides, natural ventilation was not adequate in diluting gases that had settled below the flooring. Following the incident, the family added four additional windows to the north side of the building to improve ventilation (Exhibit B).

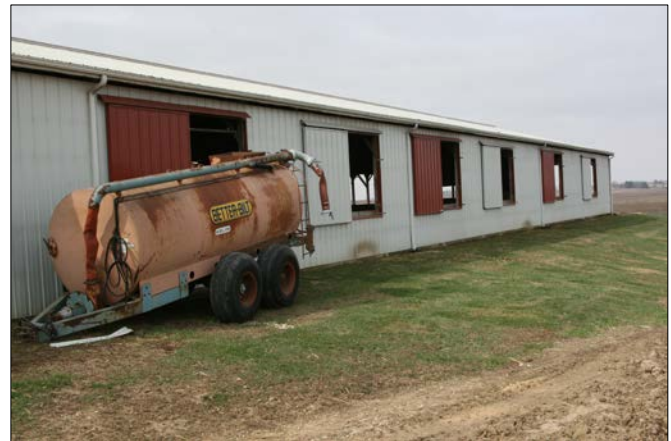
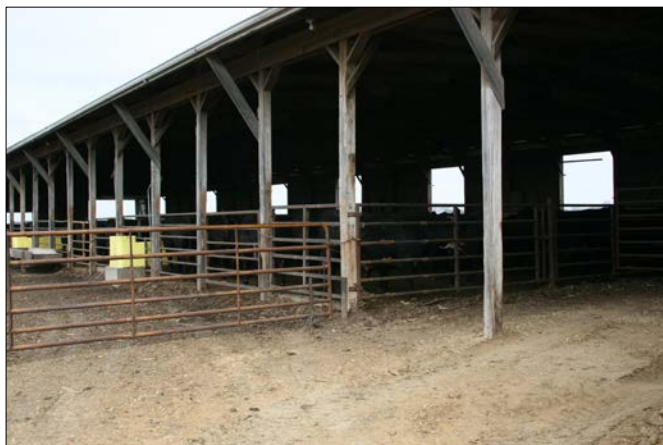
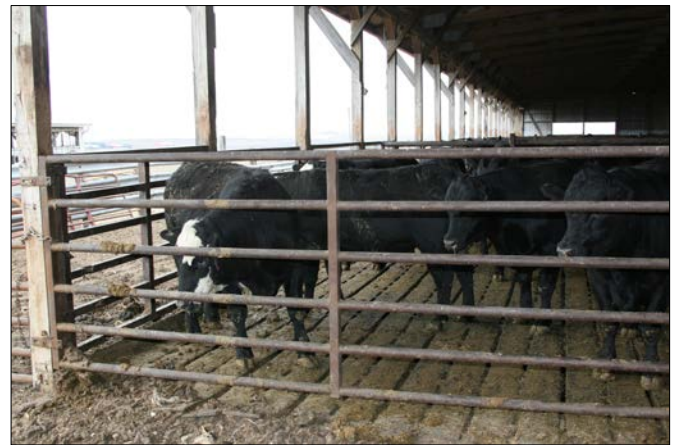
**C. South side of shed** (2014 photos)

A deep manure storage pit measuring 200' x 40' x 8' deep ran under sections of concrete slab flooring on the south side of the building. The pit was sectioned into five compartments and had no mechanical or natural means of ventilation. The incident occurred at the east end of the pit, after the last compartment had been pumped.

At the time the building was constructed, the flooring consisted of individual concrete slats over the manure pit. Over time, the slats would periodically break and fall into the pit. In the 1980s, the farmer replaced the individual slats with 4' x 8' sections of slatted concrete.

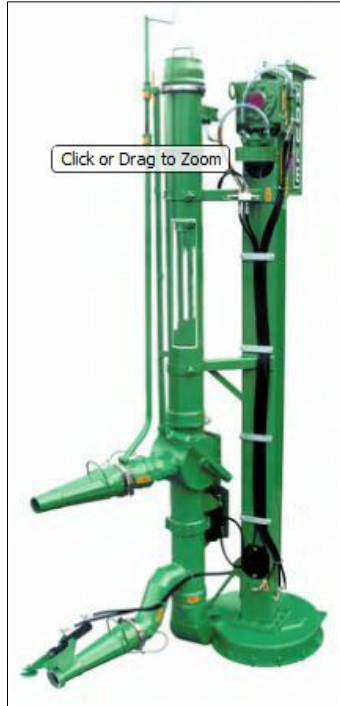
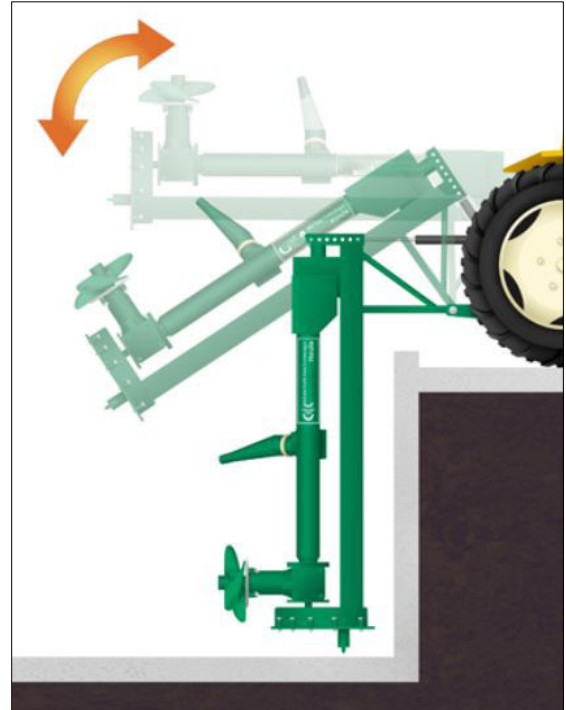
**D. Example of a vertical manure transfer pump and schematic drawing of tilting 3-point hitch attachment**

The farmer had used a vertical manure transfer pump (Exhibit D) to agitate and pump contents of the pit into a manure spreader tank. The transfer pump was attached to his tractor's 3-point hitch and was powered by the tractor's power take-off (PTO).

The pump's agitator was usually run for up to an hour to mix the solids and liquids in the manure, prior to pumping. Agitation nozzles near the bottom of the pump could be rotated 180 degrees to control the intensity of agitation. After adequate mixing, the liquid slurry was pumped to the spreader tank (shown in Exhibit B). When the spreader tank was full, it was driven to the field and the slurry was applied to the field. Manure in the pit was agitated for another half hour prior to pumping the next load; this process was repeated until the entire pit was emptied.

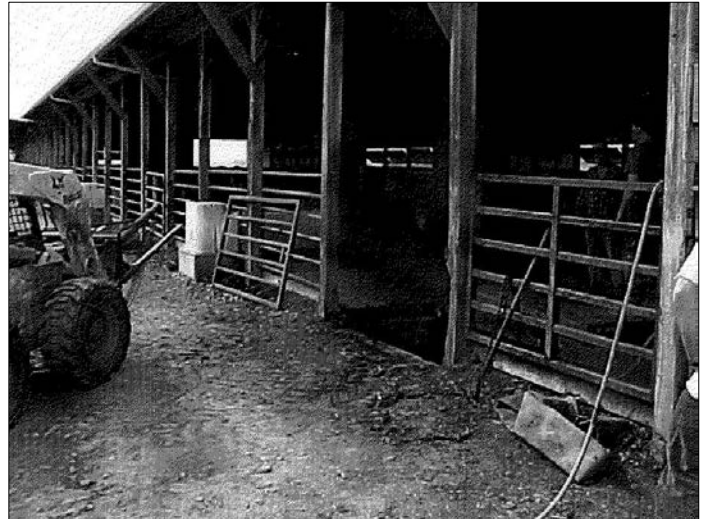
**E. South side of building showing open section gate and flooring where pump was used**

In preparation to empty the pit, a section of livestock gate was removed from the south side of the building, and a skid loader was brought in to remove a 4' x 8' section of concrete flooring (Exhibit E). The tractor was then backed to the opening, and the vertical pump was lowered into the pit.

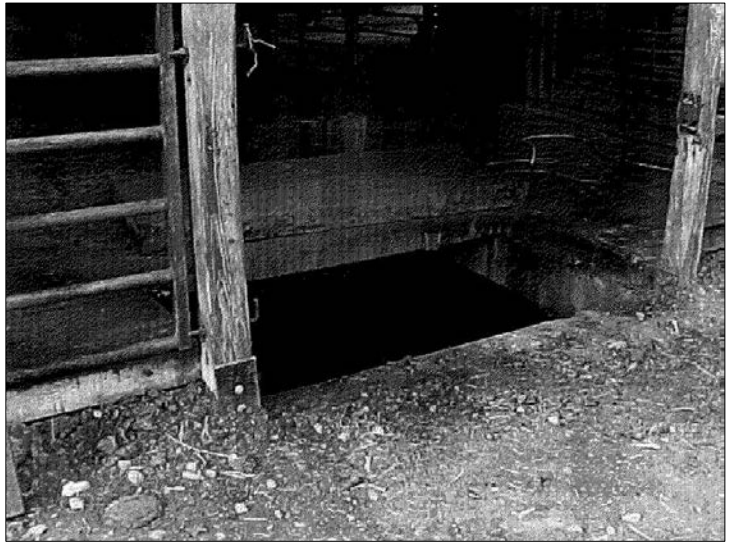
### F. Access to pit

After the pit was emptied, the farmer climbed down along the horizontal supports of the pump to enter the pit (Exhibit F). He was wearing knee-high rubber wader boots and had taken a garden hoe, presumably to retrieve the log chain that had fallen into the pit several days earlier. At some point, he fell backward, landing face-up in the liquid. It is not known if the employee witnessed the farmer's collapse or if he discovered the farmer shortly afterward.

**Manure pump had been removed following the incident**

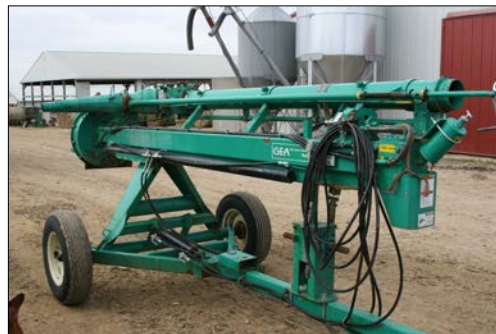
**J. Pump used at the farm in 2014**

It was not known what safety decals were on the manure pump that was used at the time of the fatalities. The family had traded for a new pump at some point following the fatalities (Exhibit J). Signage on the new pump includes a decal noting "*DANGER! Manure produces toxic gases that can cause a loss of consciousness, asphyxia, or death in a few seconds. Manure agitation can produce toxic gases in buildings built above the pit. Toxic gases can also emanate in buildings situated by the pit and /or connected to the pit by an evacuation line.*"

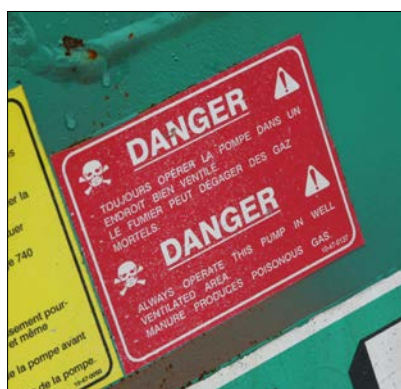
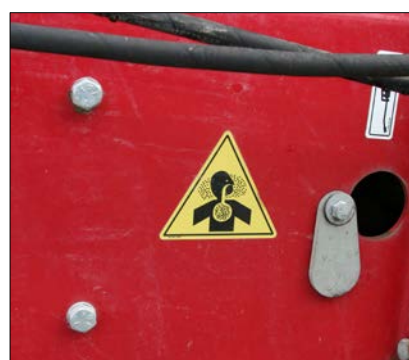
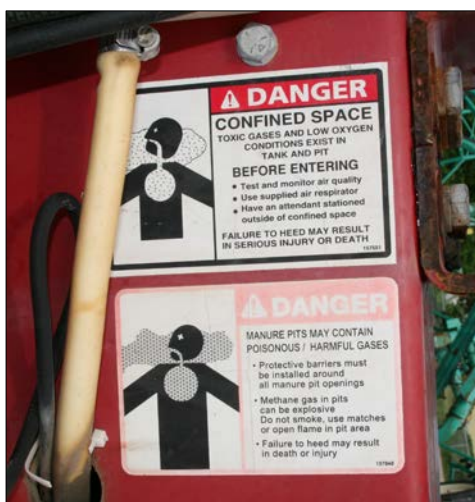
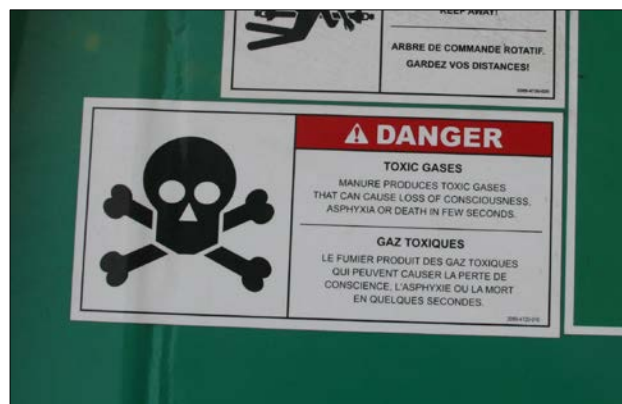
**K. Examples of manure gas warning signage on old and new equipment**

In follow up to this investigation, Iowa FACE visited a local implement dealership that sold new and reconditioned manure pumps. Various safety decals pertinent to manure gas hazards were present on older pumps, including one which had only a graphic depiction (Exhibit K). Not all safety decals were intact on some older pumps that had been traded and were awaiting reconditioning.<sup>3</sup> It is important that owners maintain safety decals on equipment and replace those that are missing, torn, or corroded. New decals are typically available through dealerships that condition equipment for resale.

None of the pumps at the local dealership had signage warning against “climbing down the pump” as a means to enter the pit. This hazard was not identified or addressed in operator manuals for new pumps at the dealership, although operator manuals did prescribe following confined space entry procedures. Climbing down pumps may not be an uncommon practice to access pits, as it has also been described in a prior FACE investigation report involving a manure gas fatality (94MN057). Equipment manufacturers should consider incorporating a warning decal and instructions advising against using the pump as a ladder to access the pit.

#### **7. Equipment owners should assure that manure gas warning decals are present and intact on manure transfer pumps and tanks. Equipment manufacturers should consider incorporating safety labels that warn against using the pump to access a pit.**
