## MIFACE INVESTIGATION: #03MI134

### **SUBJECT: Farmer Died When Tractor Overturns to Side While on a Hill**

#### **Summary**

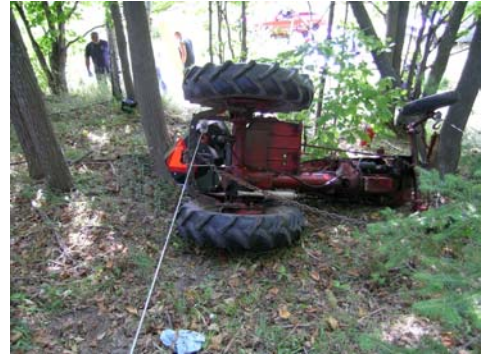
Photo 1. Final resting place of tractor

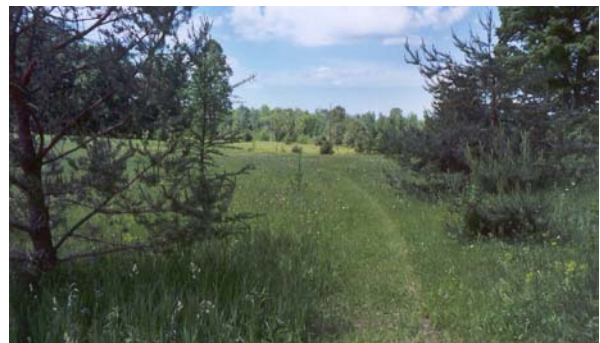
Photo 2. Path in field next to hill

On Tuesday, September 2, 2003, a 78-year-old male farmer's tractor overturned, rolling over twice and coming to rest on its side as the victim was attempting to turn while on a hill. MIFACE was informed about this work-related death by a newspaper clipping. On June 15, 2004, the MIFACE researcher interviewed the wife of the deceased, visited the incident site and viewed the tractor involved in the turnover. The victim's wife permitted the MIFACE researcher to take photographs of the incident site and the tractor. During the writing of the report, the medical examiner's death scene investigation report and police department reports and photographs were obtained. Photos 1 and 3 are police department photographs taken at the time of the incident. MIFACE took Photo 2 at the time of the site visit.

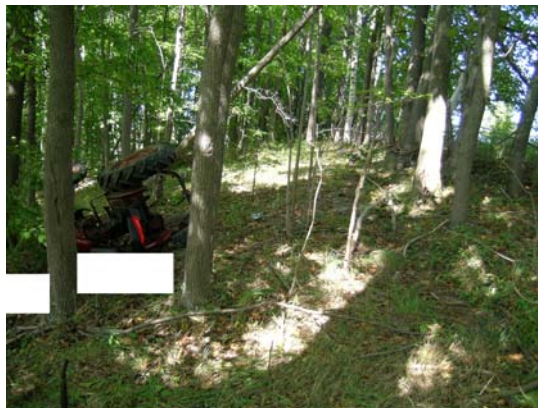
It is unknown if he stopped the tractor due to a medical emergency or if he had reached the desired place where he was going to trim the trees at the base of the hill. It is unknown when he unhooked the trailer from the tractor. The chainsaw was found nearby at the base of the tree-covered hill. The victim’s home was at the top of hill, whose slope was estimated between 20-30%. When he started up the hill, the trailer had already been disconnected from the tractor. After backing the tractor up to nearly the top of the hill, he turned the steering wheel to the left. His tractor tracks showed that the victim was able to turn the tractor and that it was “sideways” on the hill. Photo 3 shows the final resting place of the overturned tractor. There was evidence that the tractor tires were slipping in the dirt. The tractor was unstable because of the slope of the hill. The tractor overturned to the side and rolled down the hill. The seat and rear axle landed on the victim’s back and his head struck a tree stump.

Photo 3. Resting place of tractor

- Equip older tractors with a rollover protection structure (ROPS) and a seat belt; the local county extension agent, local equipment dealer or equipment manufacturer should be contacted to see if a retro-fit ROPS/seat belt system is available.
