MIFACE INVESTIGATION: #03MI193

SUBJECT: Farmer Died When Electrocuted While Welding Feed Bunker Wagon

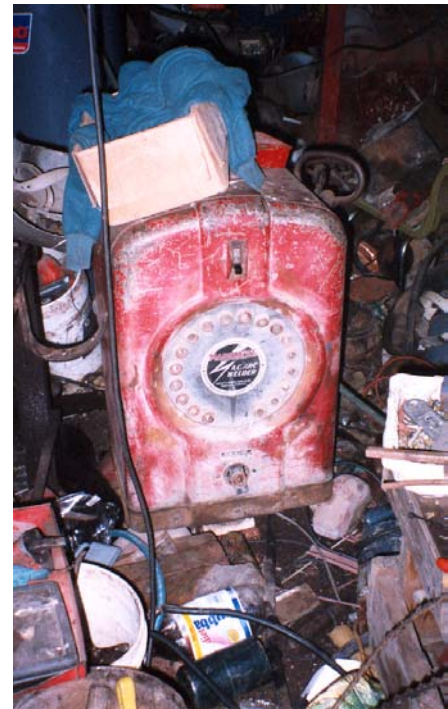
Figure 1. Welder in wooden building

The welder was an old Hobart brand A.C. arc welder (See Figure 1). The welder's power cord covering and insulation was damaged which exposed the conductors (See Figure 3). The welder cables were not available to the MIFACE researchers. The condition of the cable insulation is unknown. The caretaker explained that they had been stolen shortly after the incident. The researchers were told that the first set of welding cables were approximately 10 years old and approximately 12-foot long. The second set of welding cables that were "spliced" to the first set was also not available for inspection. The victim welded with rods that were obtained as discards from other businesses or bought by the victim at auction. The welding rods were stored in the shed in open containers, on open shelves or on the floor.

- Maintain equipment in proper operating condition.

Maintaining equipment is integral to safe operation of the equipment so that it can provide the protection it was designed to do. It is unknown if the victim was able to make an association between the “ouch” he was receiving and the poorly maintained condition of the arc welder and cable leads. The individual who lived on the property and worked the farm with the victim permitted the victim to continue to use the defective welder. It is imperative that when items are known to be in need of repair that the items are taken out of service, repaired or scrapped. A new welder had been purchased, but was not being used. Insulation on welding cable leads must be maintained to ensure the integrity of the leads and to ensure that workers are not exposed to electrical current

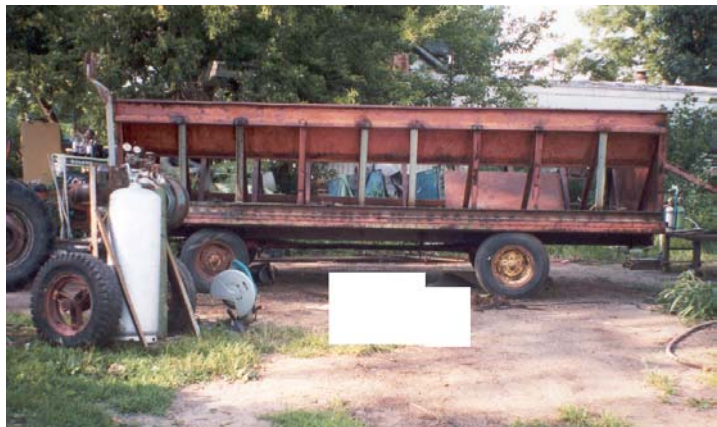
The victim was rebuilding a feed bunker wagon (See Figure 2). He backed the wagon into position with a

Figure 2. Feed bunker wagon

tractor, parking the wagon on sandy soil outside of a small wooden shed that contained junk metal, the welder, tools, electrical receptacle box, and other debris. The wagon was 18 feet long, six feet wide and the wagon bed was 28 inches from the ground. The front wheel where the victim was found was approximately 4 feet 6 inches from the front of the wagon. The beam under the hay wagon that the victim was resting against when he was found was 21 inches above the ground.

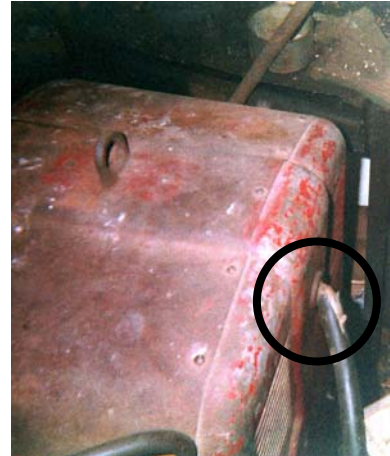
Figure 3. Damaged insulation on electrical cord

When looking at your equipment or environment, other potential safety issues, such as the need for a portable ground fault circuit interrupter (GFCI) may be identified. GFCIs are available for 240-volt electrical equipment. The electrical equipment plugs into the GFCI, and the GFCI plugs into the wall. An unintentional electric path between a source of current and a grounded surface is referred to as a “ground fault”. Ground faults occur when fault current is flowing, in effect, electricity is going to ground. Fault currents can occur when there is bad insulation, nicks, cuts or cracks. A person’s body can provide a path to ground for this current.

According to the police report, the outlet the welder was plugged into had no cover plate, had visible exposed conductors, and had other items plugged into it. It is likely that the victim’s welding setup would not have functioned with a 240-volt GFCI due to the exposed conductors on the electrical cable/plug attaching the welder to the wall receptacle (See Figure 3). Although GFCIs are not normally used with welders in farm settings, a GFCI would have detected if there were a current leakage in the electrical cable between the welder and the electrical outlet. The electrical circuit would have been interrupted and the welder would have turned off, indicating to the victim that the power to the welder was “unsafe”. NOTE: A GFCI may provide protection from the “wall to the welder”. A GFCI will not protect you from faults between the “welder and the work”. Because a GFCI cannot protect you from faults between the “welder and the work” using proper welding technique and personal protection equipment while welding is crucial.

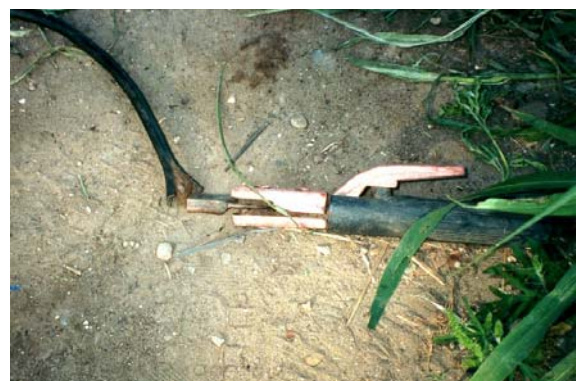
According to the victim's caretaker, the victim would conduct welding operations the same way each time due to his functional disability. The victim's normal work procedure was to "splice" two sets of welding cables together and lay them down on the ground on a 2-inch x 12-inch piece of wood (See Figures 4-5). He would not insulate the splices for protection. The victim would wear a welding helmet and welding gloves during the welding operation. He would lay and/or stand on a blue rigid foam insulation board. The victim would position all equipment, turn on the welder (90 amps), and weld.

Figure 5. Un-insulated splice on bare ground

Although it is unknown how the victim would usually “splice” the cables, on the day of the incident, he attached the electrode holder directly to the cable wire. The un-insulated connection was lying on bare ground.

According to his caretaker, some atypical circumstances were present on the day of the incident. The victim had not placed the spliced cables on the 2-inch x 12-inch piece of wood (See Figures 4-5). He was not wearing his welding gloves and he was not welding while lying on the rigid mat under him. He was working alone, which was highly unusual for him. Spare rods were lying next to the victim’s location (See Figure 6). He had placed the welding rod in the stinger but the rod had not been lit, indicating the victim had not been in the process of welding when he was electrocuted. The police report did not indicate that there were used rods found near the victim.

Establish safe work procedures when you need to “splice” a welding lead. The victim used an unsafe practice when he attached the electrode holder to the wire cable. Splices should be accomplished using only approved components and commercially manufactured welding “cable connectors” that can be found in welding supply stores and some farm supply stores.

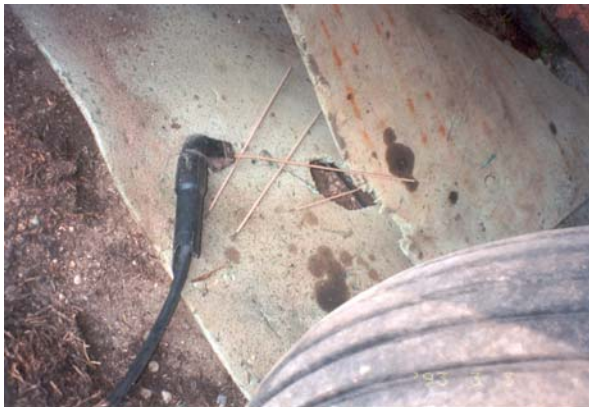
Figure 6. Stinger on mat, unused welding rods

It appears that the victim changed the electrodes with his bare hands. This unsafe practice should be forbidden. Never change electrodes with bare hands or wet gloves. When welding, avoid wrapping electrode cables around your body.

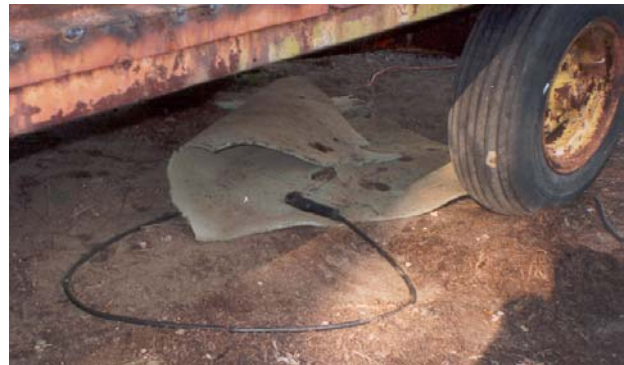
Figure 7. Flexible mat under feed bunker wagon

The police pictures taken at the time of the incident show a flexible foam mat was present under the feed bunker wagon; pictures indicate the victim was probably not lying on the mat while he was under the wagon (See Figure 7).

Rigid foam building insulation sheets, although possibly somewhat an electrical insulator, are not intended for such use. To provide a greater degree of protection, an insulated electrical safety mat should be used and laid on the ground to provide a surface to work on as well as provide additional protection – the safety mat is nonconductive and provides protection for the individual on the mat to prevent an individual from being a “path” for the electrical current to ground. Several sources of safety mats can be found on the Internet using the search term of “non-conductive mat”. One non-conductive mat source identified by MIFACE had a mat of 4’x10’ retailing for under \$275.00.
