FROM: Iowa FACE Case No. 2005IA015

SUBJECT: 84 year-old farmer died when tractor overturned while feeding cattle on hillside

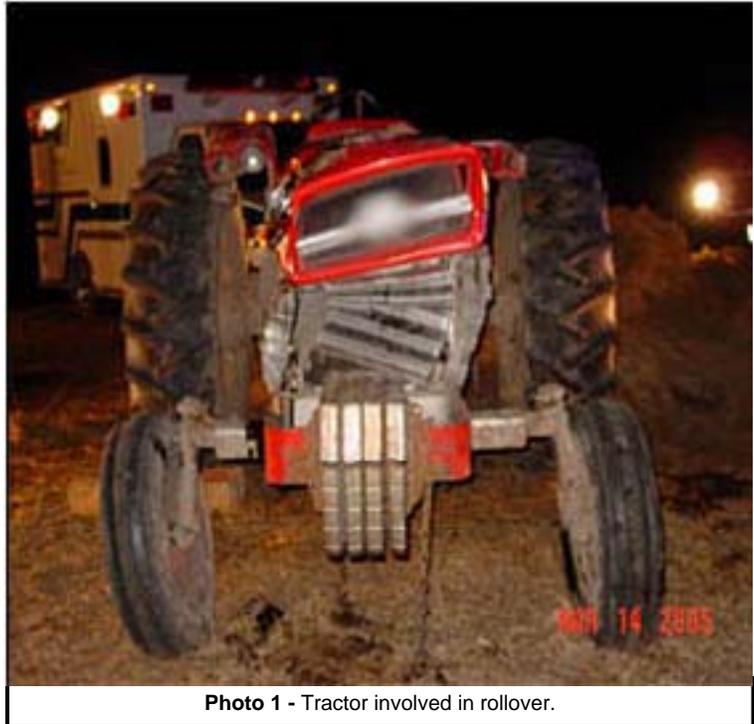
Photo 1 - Tractor involved in rollover.

The victim owned and operated a 1966 tractor, which was never fitted with a rollover protective structure (ROPS). The tractor appeared to have three forward facing and one rear facing lights based on the sheriff photographs, but their operability and illumination capability were indeterminable following the incident. The tractor also had a tire that needed to be pumped up each day and a damaged right front wheel bearing.

Recommendation 1: *Farmers should install rollover protective structures (ROPS) on tractors.*

Discussion: ROPS with seat belts are the most effective prevention strategy to reduce traumatic injury from overturns. ROPS are open heavy metal frames or frames within cabs that enclose tractor operators. They do not prevent tractor overturns but rather create a survivable environment around the operator. ROPS are available on newer tractors, but the decedent was driving an older one without a ROPS. Tractors can be retrofitted with ROPS and a seat belt at a reasonable cost, and programs that provide incentives to install and retrofit ROPS may be beneficial.

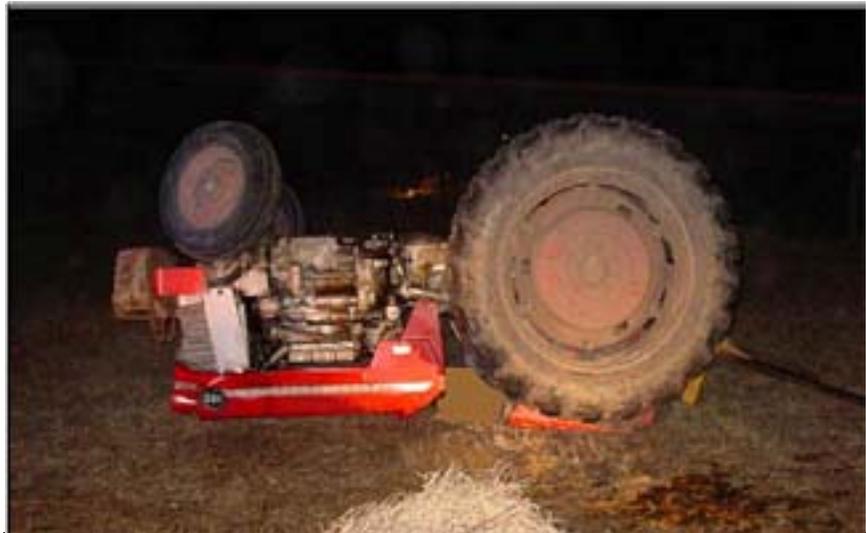
Tire track measurements suggest that the tractor was travelling down the hill at a fairly moderate speed in the wet terrain. Based on medical examiner investigations and an interview with family, two probable scenarios were offered to describe the incident. In one, the tractor appeared to have run over a large hay bale and overturned while traveling downhill. The tractor likely completed 1.5 full revolutions and stopped upside down, pinning the victim. Another scenario was that the victim had attempted a left turn to avoid the fence and ditch at the edge of the hillside, and that the sharp left turn along with the damaged right front wheel bearing and tire led to its instability. The tractor overturned on its right side and trapped the victim. Lack of artificial light and the speed of the tractor may also have been contributing factors.

Photo 2 - The final, inverted position of the tractor with pinned victim.
