MIFACE INVESTIGATION: #03MI053

SUBJECT: Farm Owner Crushed Underneath Rotary Mower While Changing Blades and Untangling Wire Wrapped On Cutting Blades

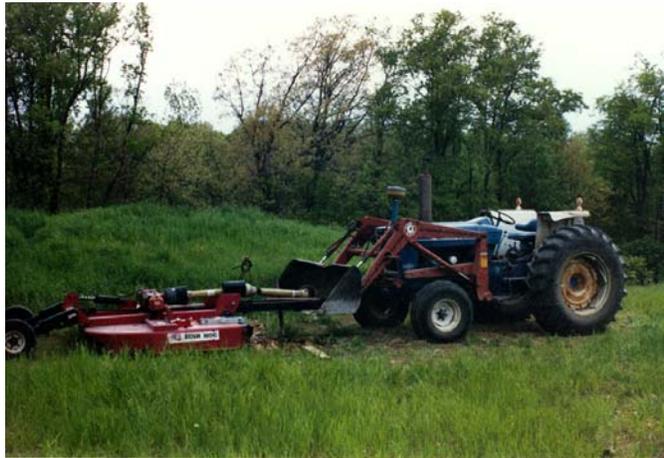
Figure 1. Incident Scene

On May 26, 2003 a 56-year-old horse farm owner was killed when he was crushed under a Bush Hog Brand Rotary Cutter Model 3210 rotary mower while changing the cutting blades. A few days before, he had cut a field and noticed that there was a problem with the mower. He left the mower at a location other than the utility barn. The floor in the utility barn was a concrete pad and the ground where he left the mower had what appeared to be dry mortar sand on its surface. (See Figure 1) The event was unwitnessed. According to his wife, he was planning to change the blades prior to its next use. His wife requested that he wait for her to assist him. It appears the victim used a tractor equipped with a front-end loader to lift the mower by placing the bucket under the mower tongue. It is unknown what happened next. He may have raised the front of the mower with the tractor bucket, placed wood under the tongue and on either side of the mower, then moved the tractor back about four feet with the bucket raised. Another possibility is that he left the mower tongue in the raised bucket, and placed the wood supports under the mower. He positioned himself under the raised mower with a socket wrench to remove nuts holding the blades in place. When he did not return to the house as planned, the victim's wife and daughter went to look for him. The tractor was found running about four feet away from the mower, with the bucket raised about five feet in the air. There was a chain that appeared to be unused in the bucket. There were blades and nuts on the ground. When his family members found him under the mower, the victim's wife attempted to raise the mower by placing the bucket under the mower's tongue. She was unable to do so. As she was attempting rescue, the victim's daughter drove back to the house and called 911. Emergency response arrived, removed the victim from under the mower, and took him to a local hospital where he was declared dead.

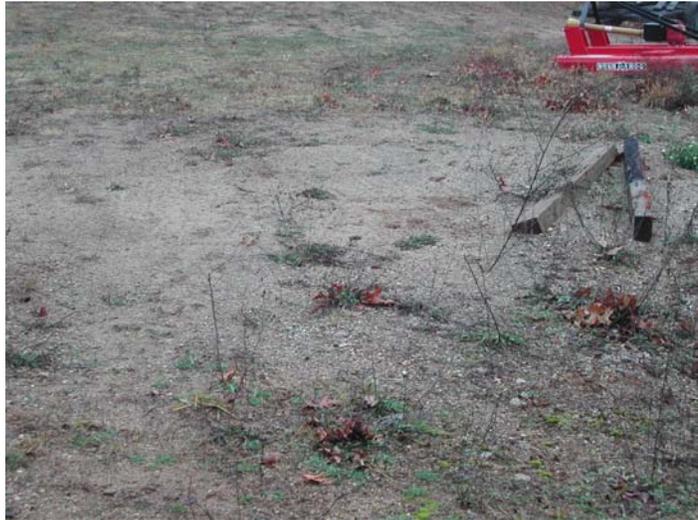
Figure 2. Location of mower while being repaired

The victim was working on a Bush Hog Brand Rotary Cutter Model 3210. According to the manufacturer's literature found on the Internet, the rotary cutter had a 10 1/2-foot cutting width and weighed 2,741 pounds. The Ford tractor he used to lift the mower was equipped with a 7600 Bush Hog Brand front-end loader/bucket. A few days prior to the incident, when using the tractor and mower, the mower ran over some fence wire. The wire became entangled in the mower blades and the victim parked the mower in a field. The ground where he left the mower was covered by a layer of what appeared to be fine mortar sand.

According to his wife, the victim normally did all maintenance and repair on the mower outside of the utility barn on a concrete pad. When he worked under the mower the victim propped up the mower with the loader bucket, chained the mower to the bucket and used boards and posts to keep it off the ground. His wife stated that he normally did the mower maintenance. Often, his wife would assist him because it required a great deal of strength to apply torque to the blades to remove them. The Bush Hog model 3210 operator's manual specified that the nuts on the blade bolts were to be tightened to 450 ft./lbs.

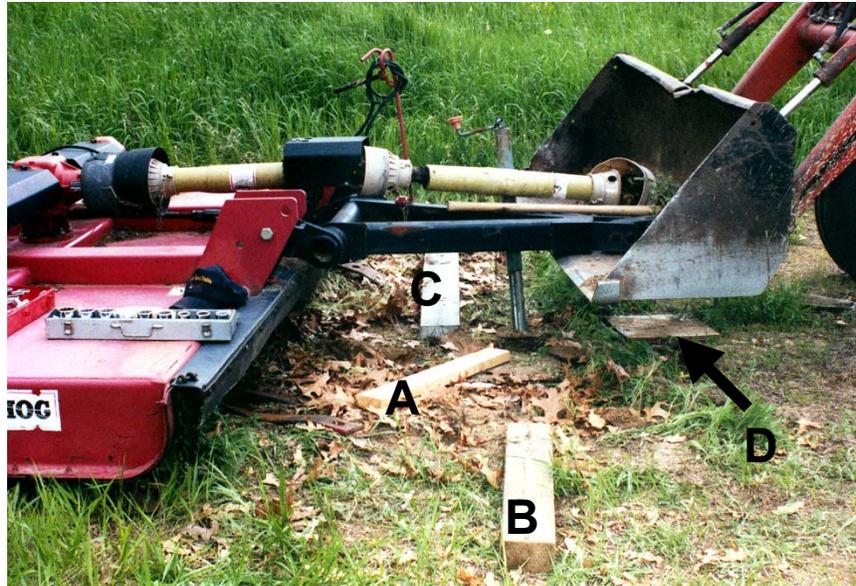
Figure 3. Wood used for mower support

The following two possible event scenarios have been developed after interviews with the deceased's wife and the responding police agency. Figure 3 shows the pieces of wood that were thought to be used as supports for the mower.

timber under the tongue toward the front of the tongue (A), and two pieces of untreated timber (B&C) one under each corner of the mower. He may have used the square piece of wood (D) as a support for the wood under the tongue. The responding police measured the treated timber (A) under the tongue; 5-inches by 3-inches and 31 3/4-inches long. The size of timbers (B&C) was not measured, nor was the square piece of wood (D). He did not block the trailing wheels to avoid wheel movement. It does not appear that the jack stand seen in Figure 3 was used as an additional support structure. After securing the mower in its raised position, he backed the tractor about four feet away from the propped up mower, leaving the bucket raised about five feet from the ground and the engine in "idle".

After propping up the mower as described in scenario 1 or 2, he began to work under the mower. Using a socket wrench, he had partially removed some dull blades. Possibly while exerting torque to remove the nuts holding the blades to the mower, the timber supporting the mower shifted. With the timber shifting in the loose soil, the mower rolled back a short distance completely dislodging the support timbers resulting in the mower fell on the victim's chest. Police found indentations in the soil where it appeared that the mower wheels had been resting

for a period of time. The police measured from these indentations to the final resting point of the mower's rear support wheels. The mower rolled approximately 46 inches away from the tractor because there is no indication that the tractor moved. The victim was pinned to the ground under the front end of the mower. If Scenario #2 occurred, vibration from the idling tractor in addition to the torque exertion may have dislodged the unsecured mower tongue from the bucket, causing the mower to fall against the timber, dislodging the timber and causing the mower to fall to the ground.

- Do Not "prop up" farm machines using angle bracing/supports during maintenance/repair procedures. Machines and equipment should be supported with solid wood blocking on solid work surfaces and according to the manufacturer's instructions.

Blocking the wheels prevent the tires from rolling. Blocks and/or wheel chocks should be selected according to the equipment's tire size, percent grade the equipment is being serviced on, the surface conditions and the vehicle's weight. It is best to use two blocks/chocks on the weighted axle since the weighted axle keeps the tire on the ground against the block/chock. If the block/chock is placed at the unweighted axle, the tire on the unweighted axle can ride up and over the block. Use blocks/chocks in pairs, one set at each tire. For most farm equipment even pine timbers will have sufficient strength to keep from crushing or rolling. Rolling can be a problem on the farm during field repair. MIFACE recommends 4"x 6" blocking rather than 4" x 4" to minimize rolling. The 6" blocks also fit more jacks.

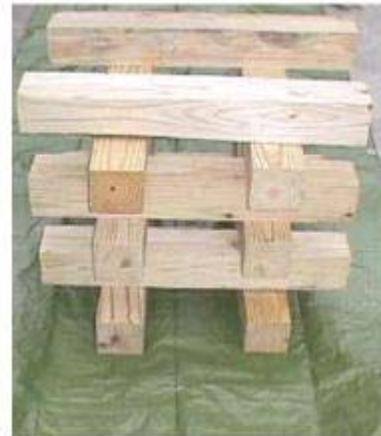
Figure 4. Example of cribbing

Cribbing should be used when the equipment must be supported at a height greater than blocking can provide. Cribbing involves placing timber in tiers that run in alternate directions. To place cribbing, raise the load and without placing yourself under the elevated load, place the cribbing under the load. (See Figure 4). Then lower the load onto the cribbing. If using a jack to raise the load, make sure the jack is on a firm foundation (use blocking timbers as required), raise the load to the maximum height the jack can safely lift to, place cribbing, then lower the load.
